Coffs Creek and Park Beach Flood Study

Final Report

May 2018

Prepared for: Coffs Harbour City Council

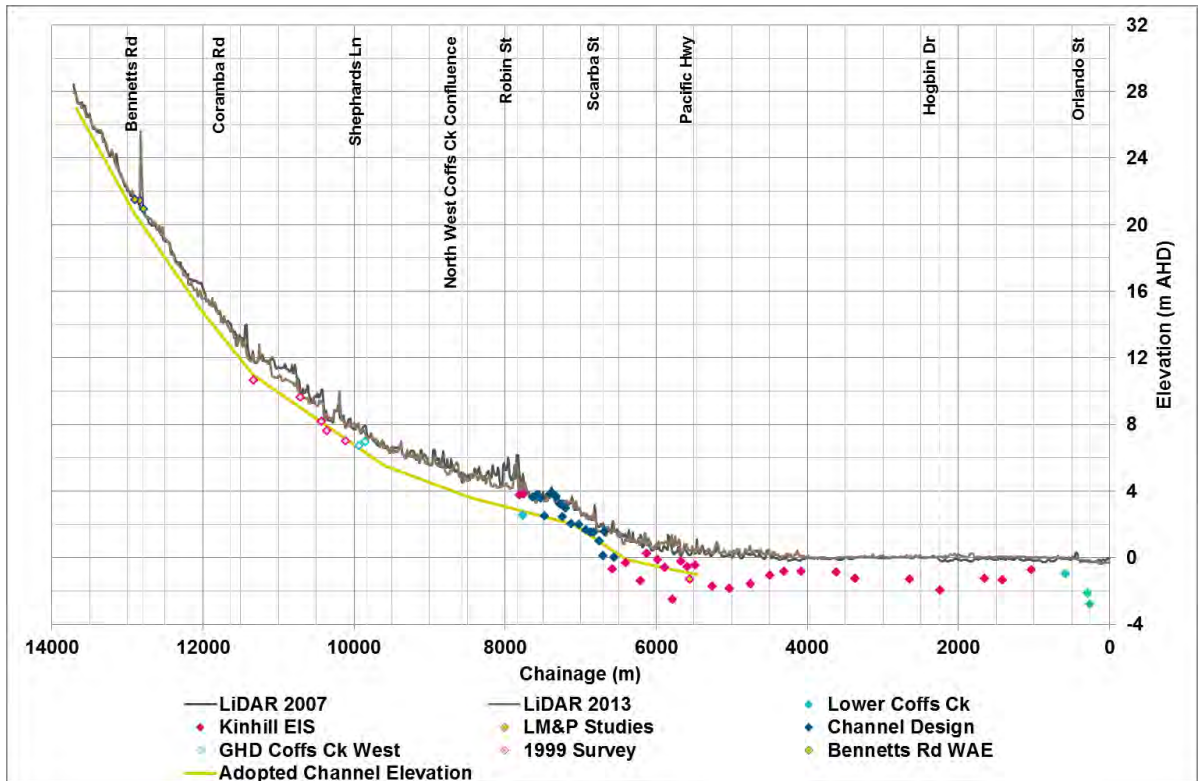
Figure 3-2 Assessment of LiDAR Survey Representation of Coffs Creek (Main Arm) Channel Topography

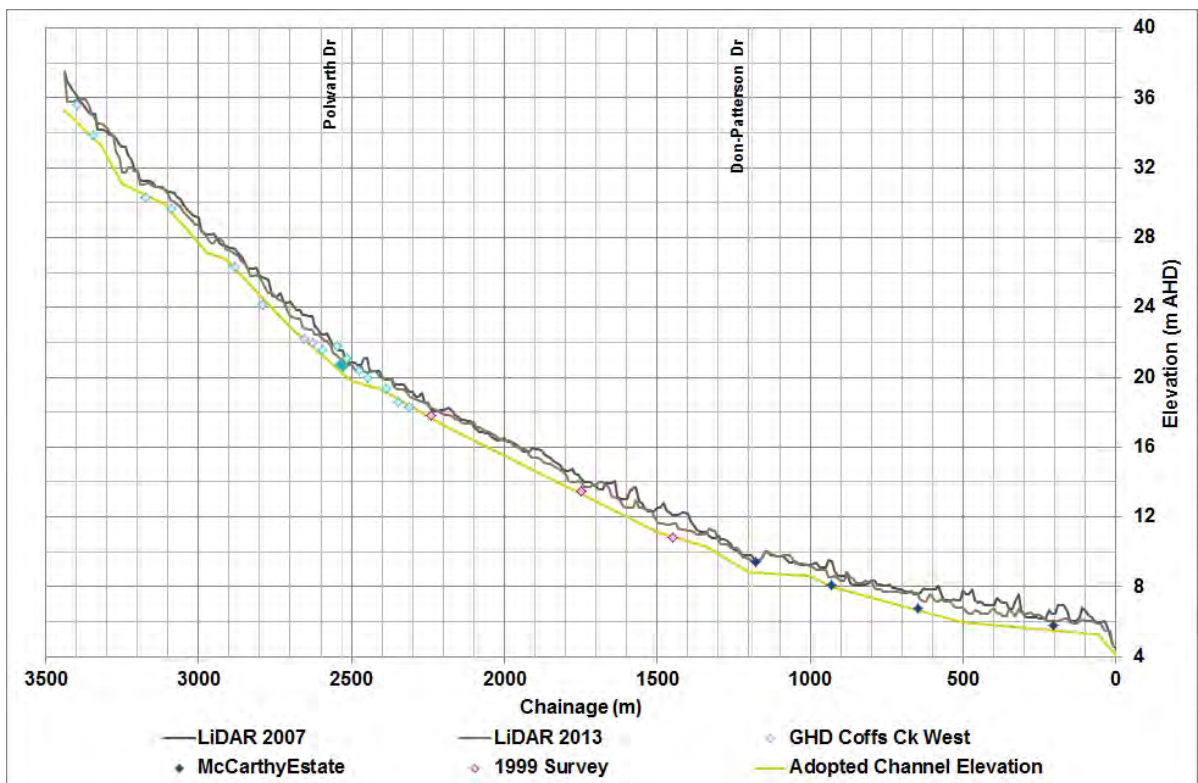
Figure 3-3 Assessment of LiDAR Survey Representation of Coffs Creek (North West Arm) Channel Topography

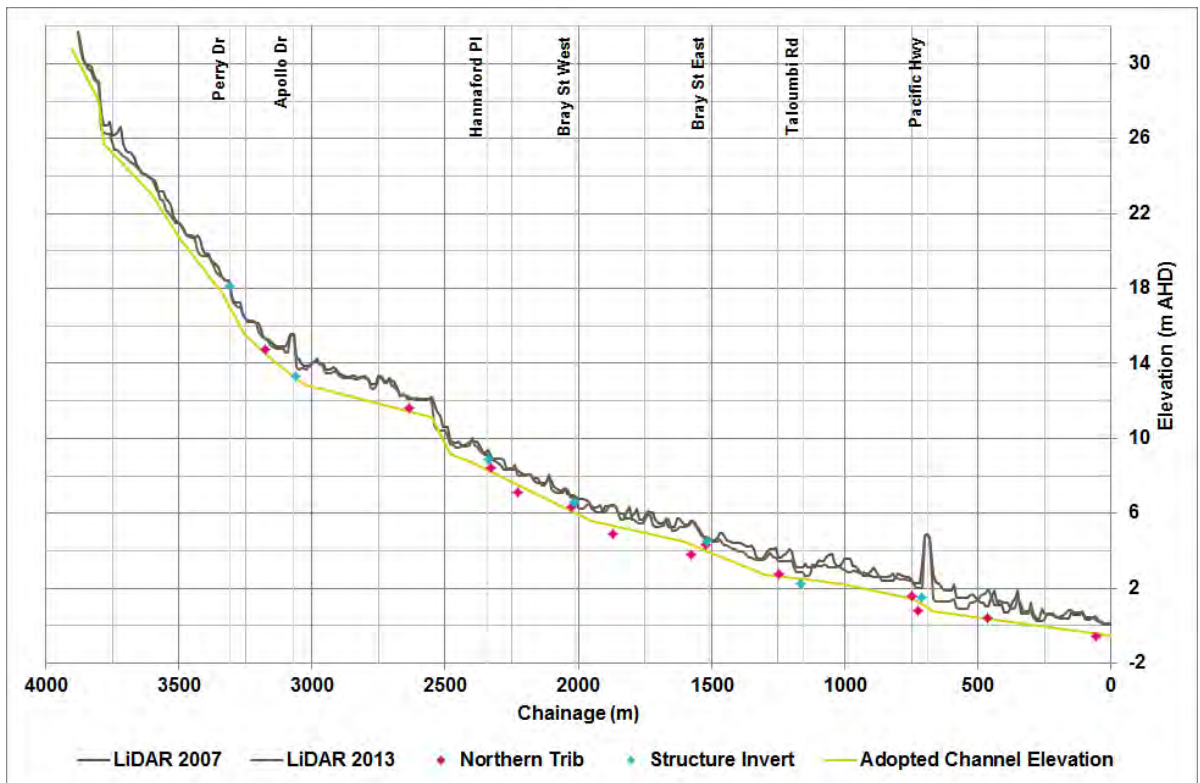
Figure 3-4 Assessment of LiDAR Survey Representation of Coffs Creek Northern Tributaries (Bray Street Arm) Channel Topography

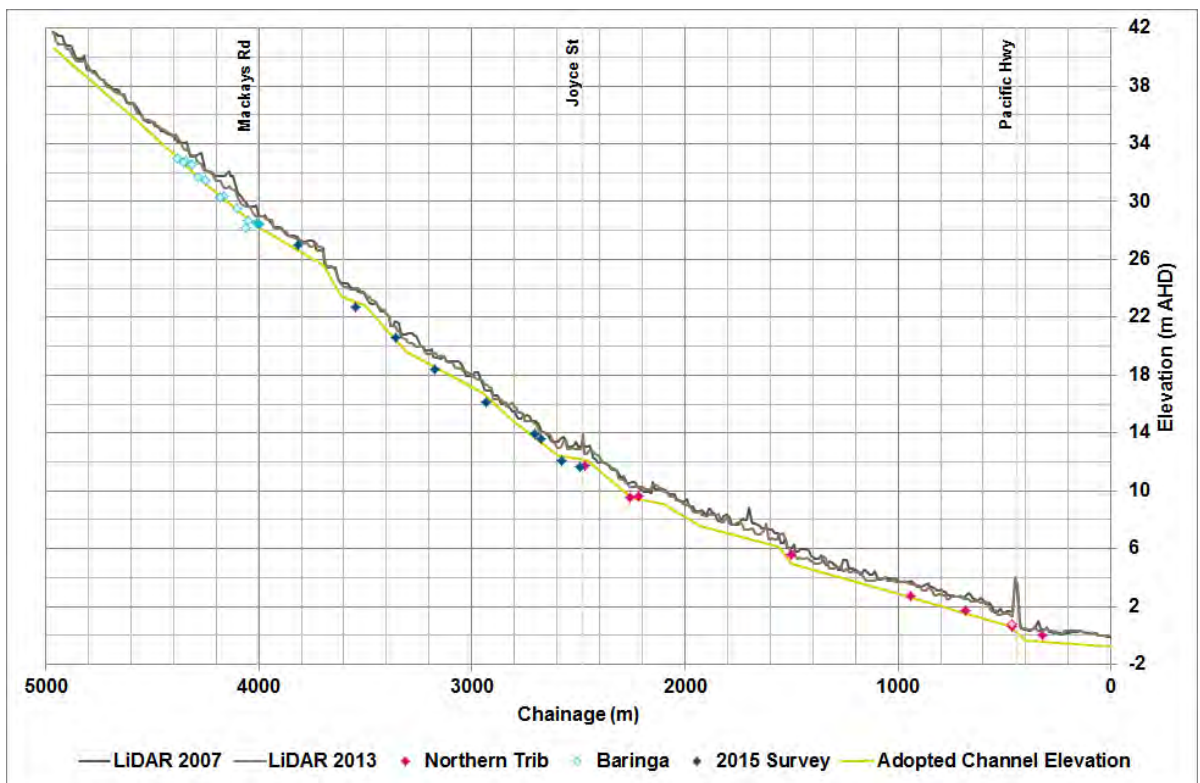
Figure 3-5 Assessment of LiDAR Survey Representation of Coffs Creek Northern Tributaries (Argyll Street Arm) Channel Topography

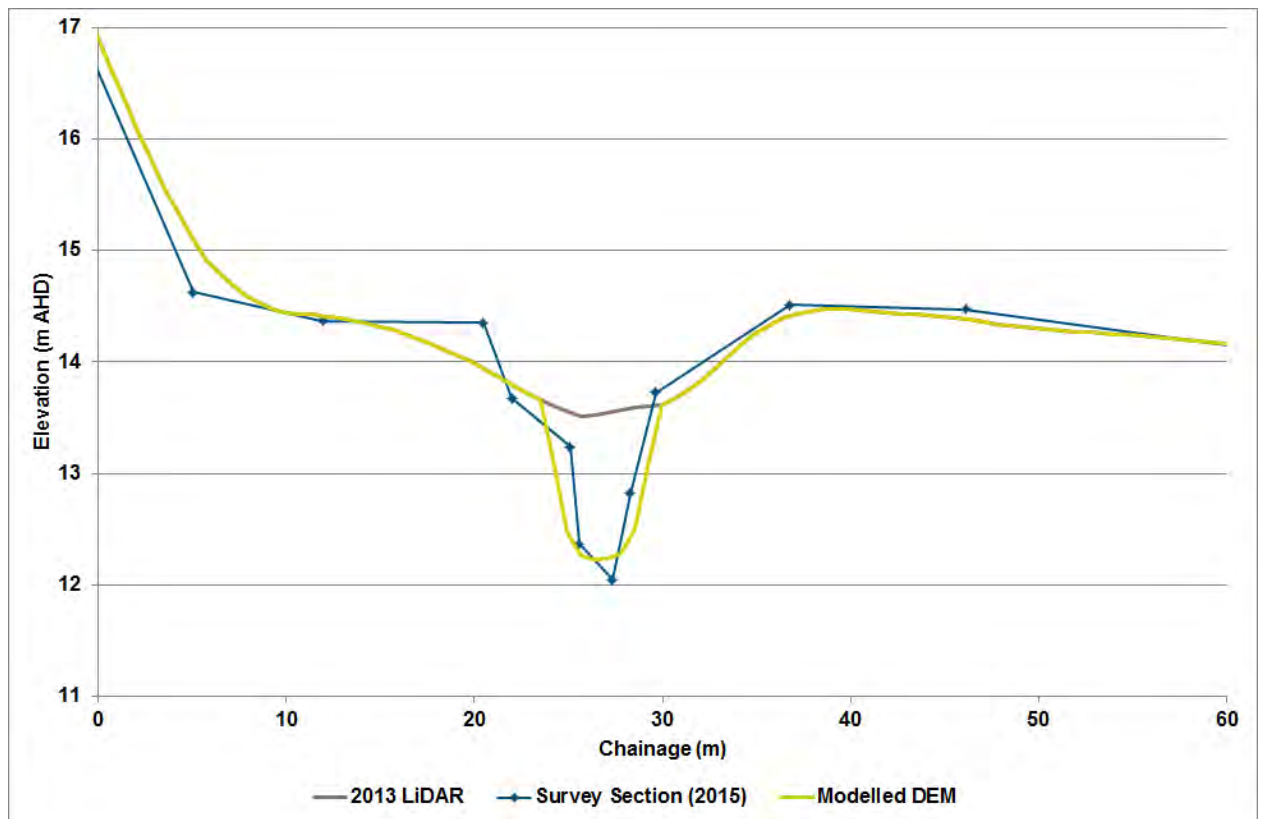
Due to the different nature of the creek channel upstream and downstream of the Pacific Highway, two different methods were adopted to define the width of the channel bed. Upstream of the Pacific Highway, the channel was lowered by one cell width (4m) to allow for a continuous flow path along the creek alignment. Bed elevations were determined from the data analysis presented in Section 3. A sample cross sections of the modelled topography, derived from LiDAR data is provided in Figure 4-2.

Figure 4-2 Sample Model Channel Section Derived from LiDAR Data Assessment (Upstream of Pacific Highway)

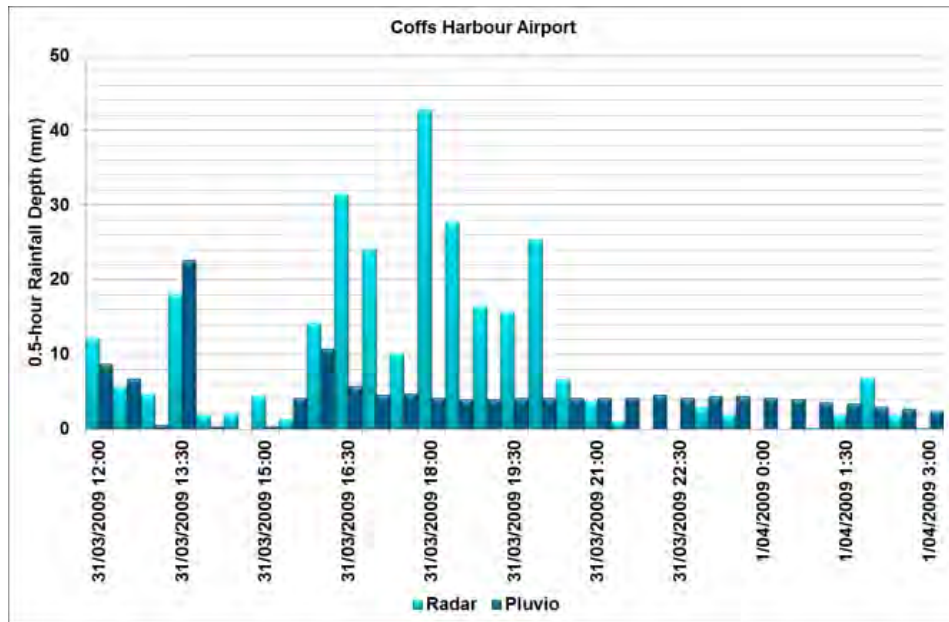
Figure 5-1 Comparison Between Recorded and Radar Derived Temporal Pattern

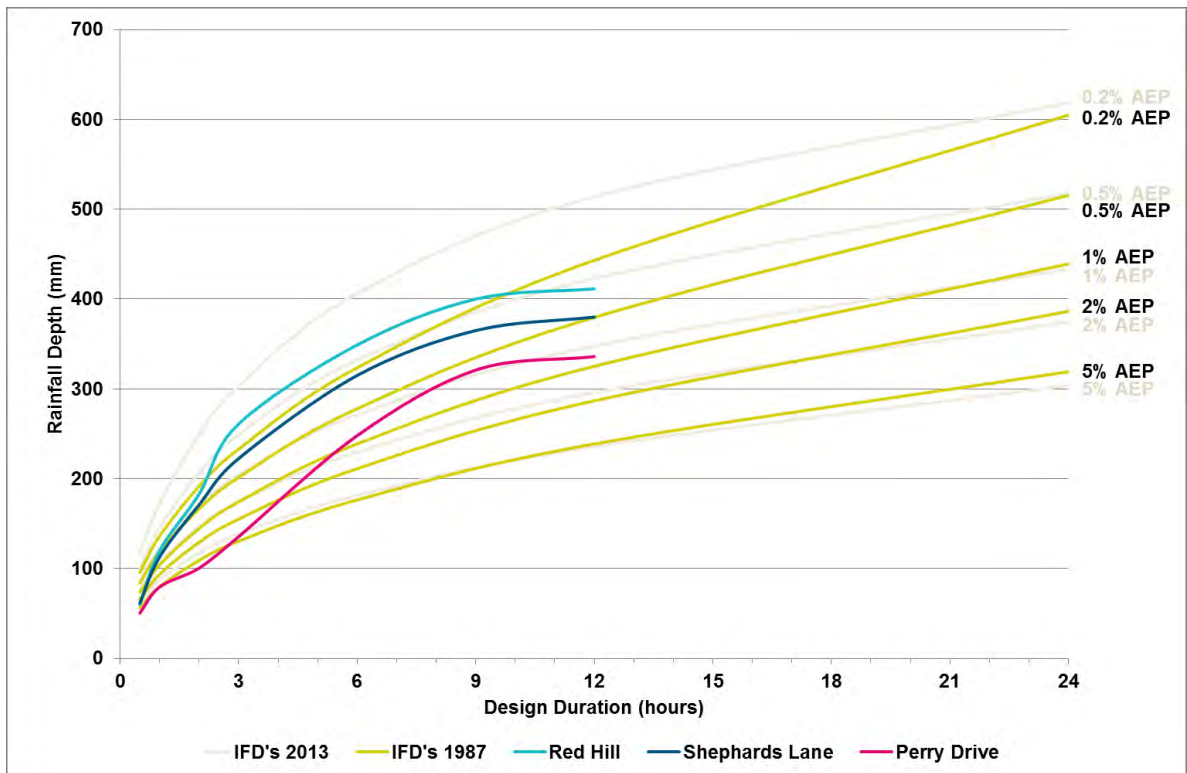
Figure 5-4 Comparison of Recorded March 2009 Rainfall with IFD Relationships

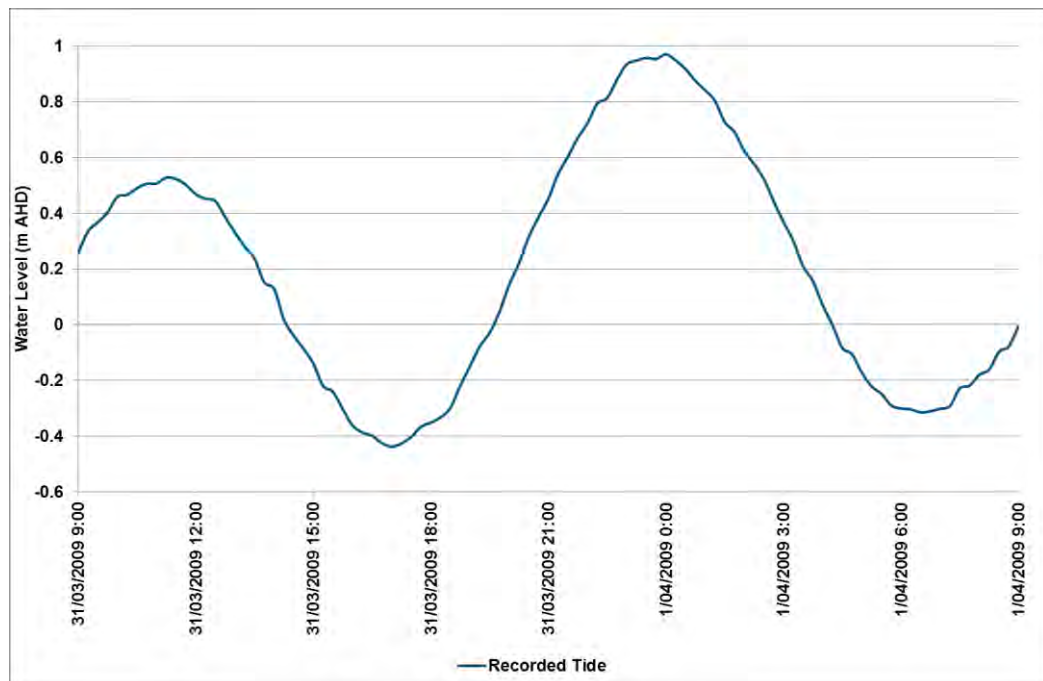
Ocean tide (water level) data was available for the March 2009 event from a continuous tide gauge maintained by MHL at the Coffs Harbour Jetty. This water level data (as presented in Figure 5-5) was used as the downstream boundary for the March 2009 event.

Figure 5-5 Recorded Tidal Water Level at the Coffs Harbour Jetty for the March 2009 Event

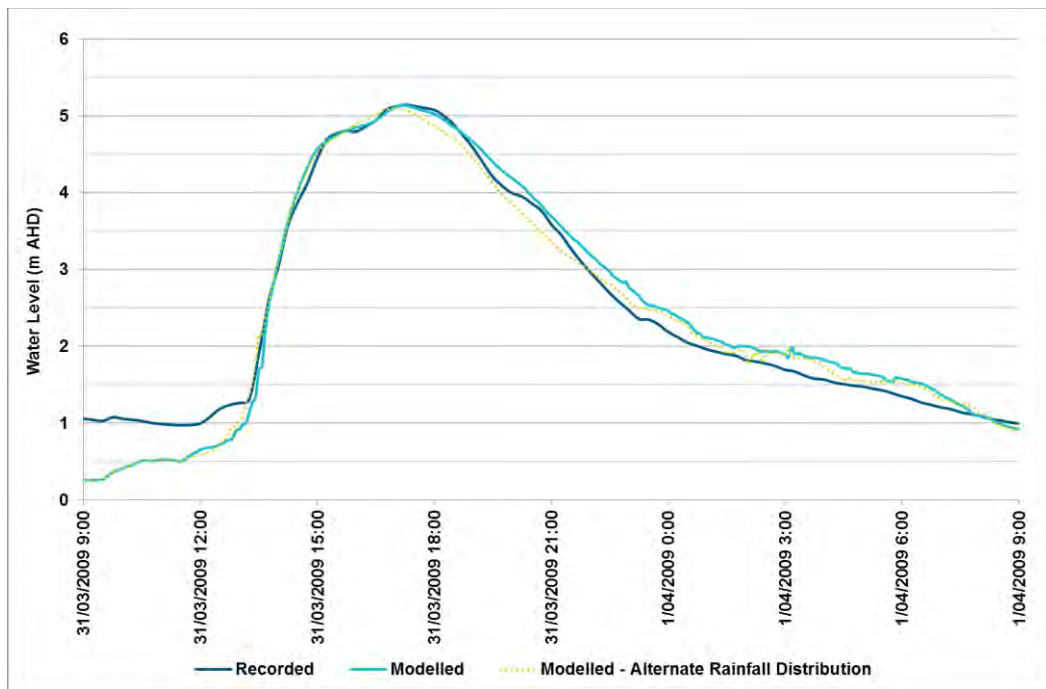
Figure 5-6 Recorded and Modelled Peak Water Level Hydrograph at Pacific Highway Bridge for the March 2009 Event

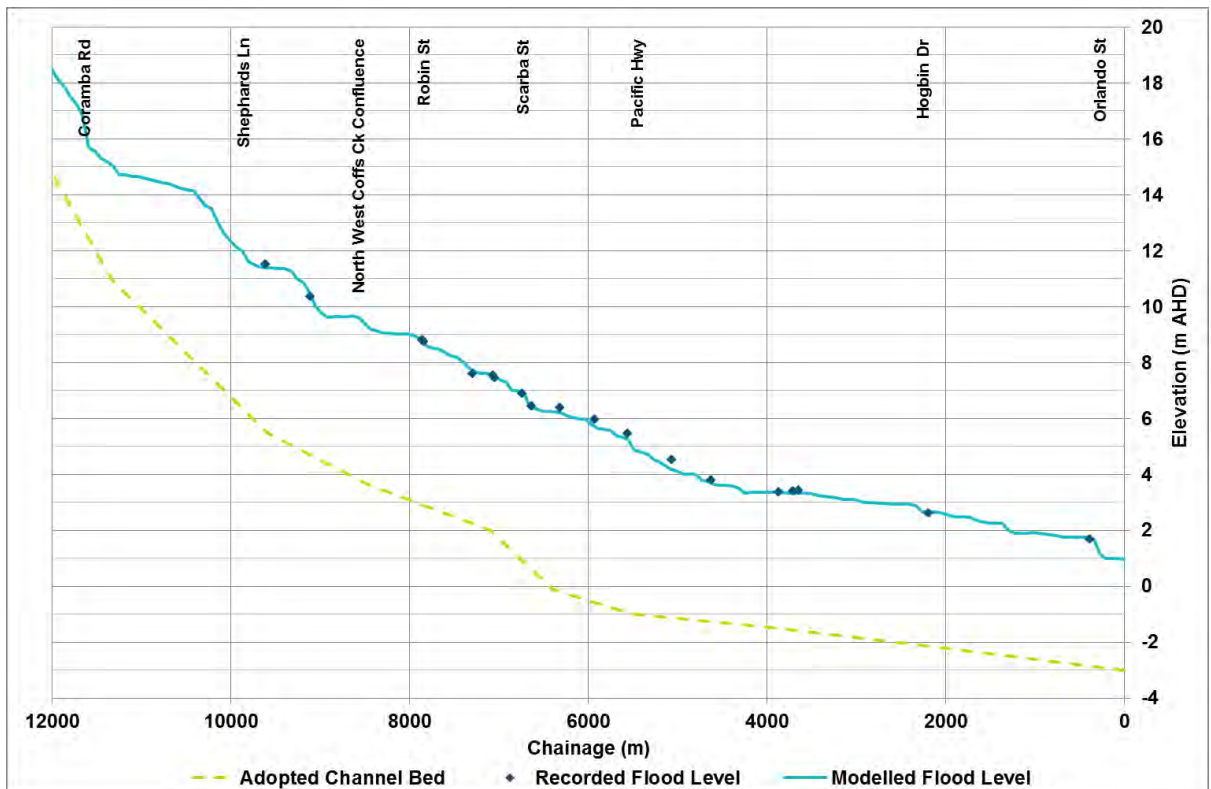
The modelled peak flood level profile for the Coffs Creek Main Arm is presented in Figure 5-7, against the available flood marks relating to Coffs Creek flooding. The modelled bed elevation is also included for reference. A similar flood level profile for the North West Arm of Coffs Creek (from chainage of 0m at the confluence with the Coffs Creek Main Arm) is presented in Figure 5-8. In both figures, it can be seen that the modelled flood profile matches well to the observed data.

Figure 5-7 Long Section along the Coffs Creek Main Arm for the March 2009 Calibration Event

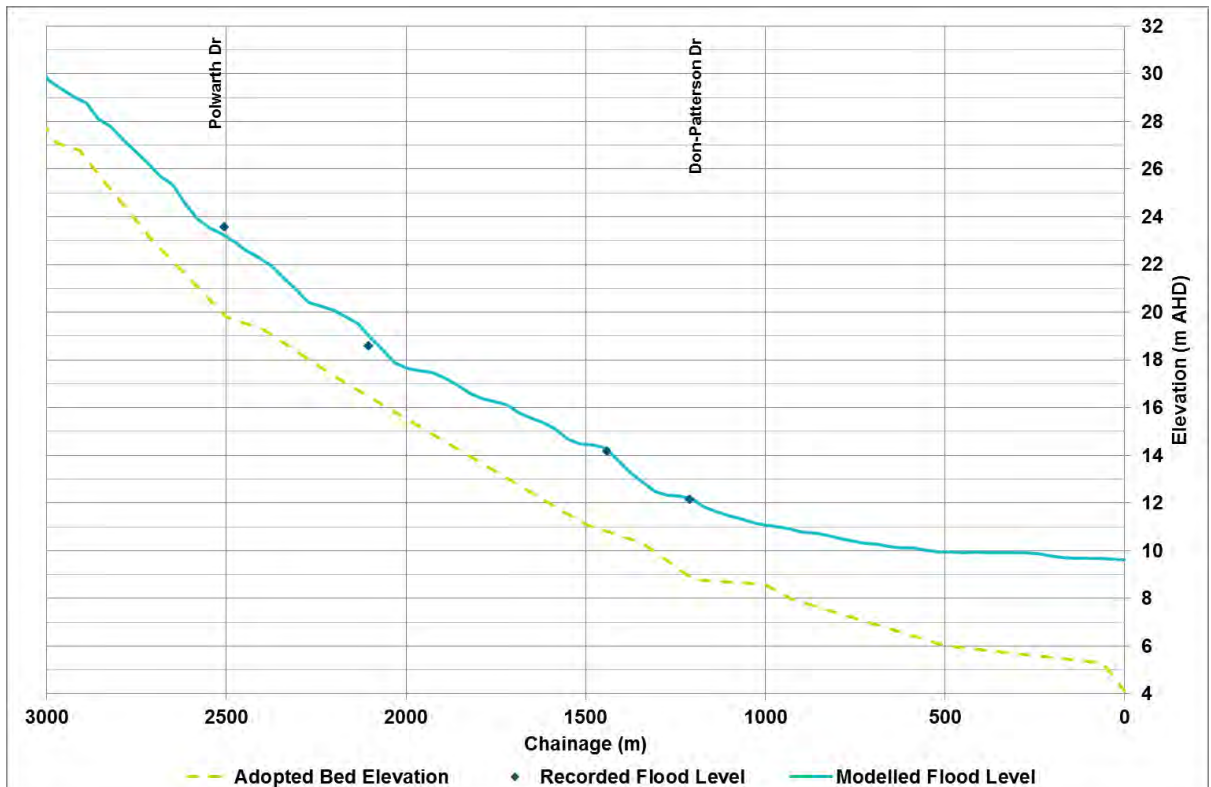
Figure 5-8 Long Section along the Coffs Creek North West Arm for the March 2009 Calibration Event

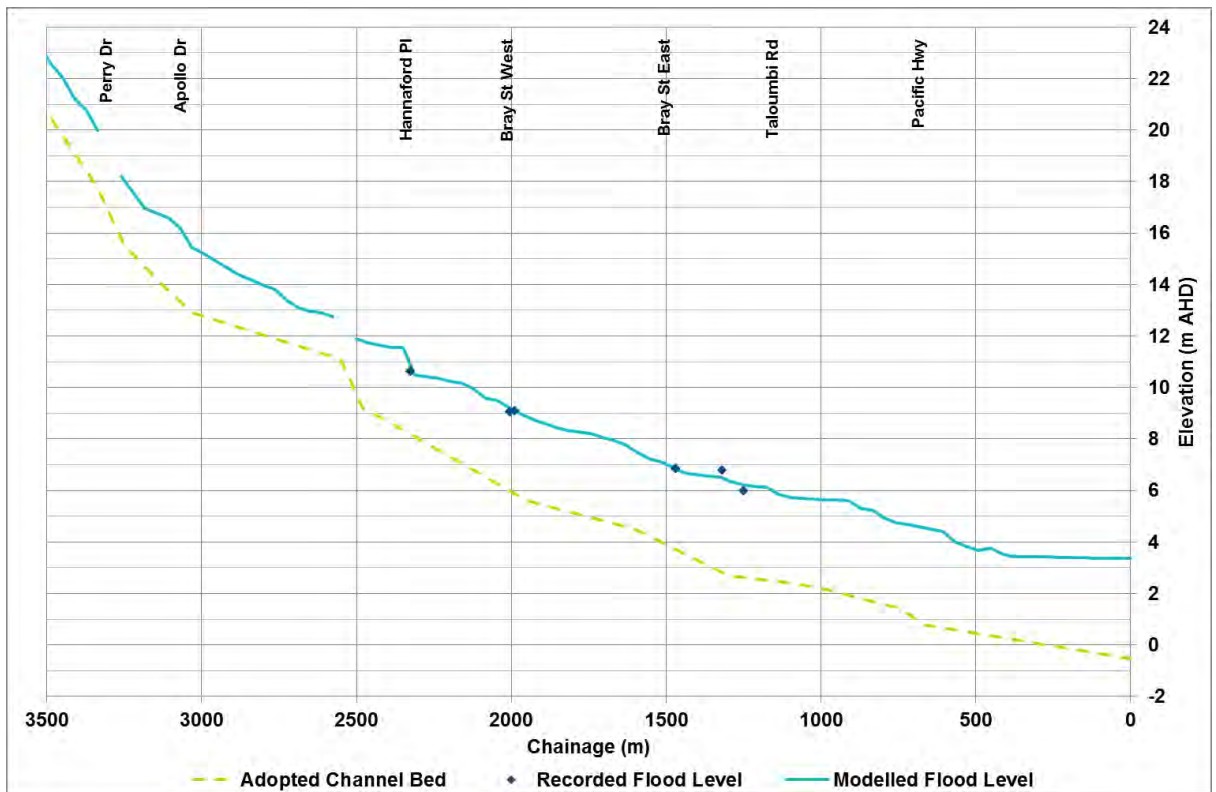
Figure 5-11 Long Section along the Bray Street Arm of the Northern Tributaries for the March 2009 Calibration Event

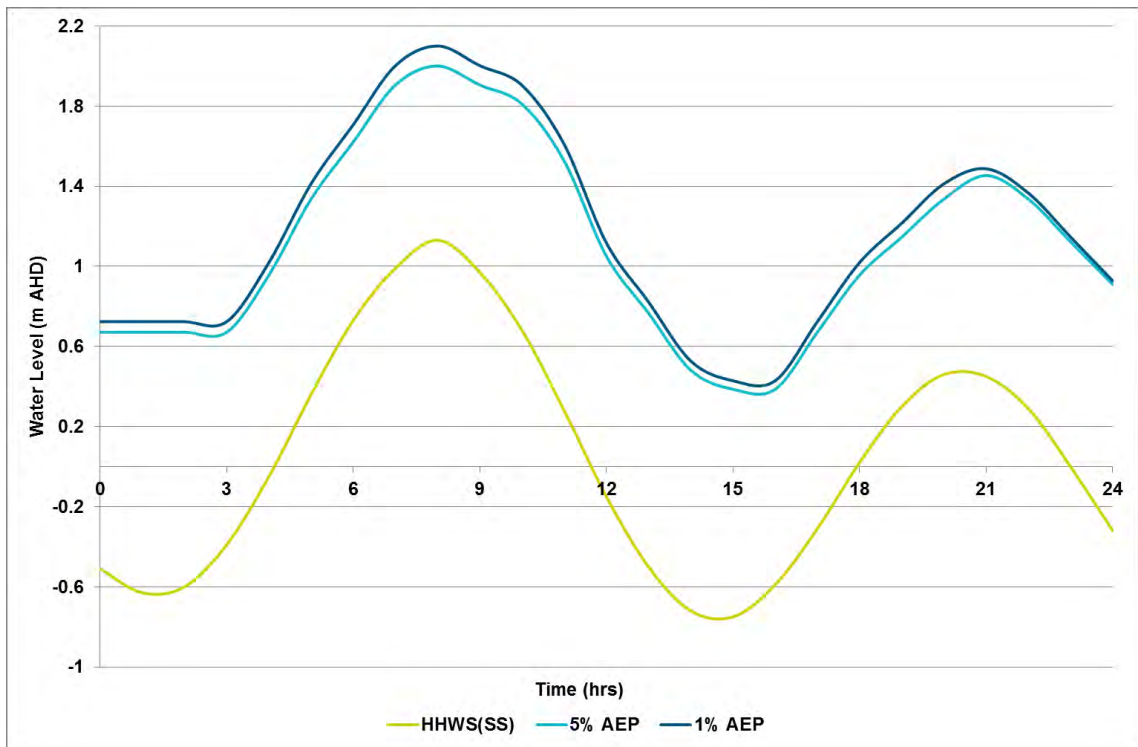
Figure 6-3 Design Ocean Water Level Time Series for Entrance Type B, located North of Crowdy Head (OEH, 2015)
