# Coffs Harbour Region Ecohealth Project

## 2014-2015

### Assessment of River and Estuarine Condition

**Final Technical Report**

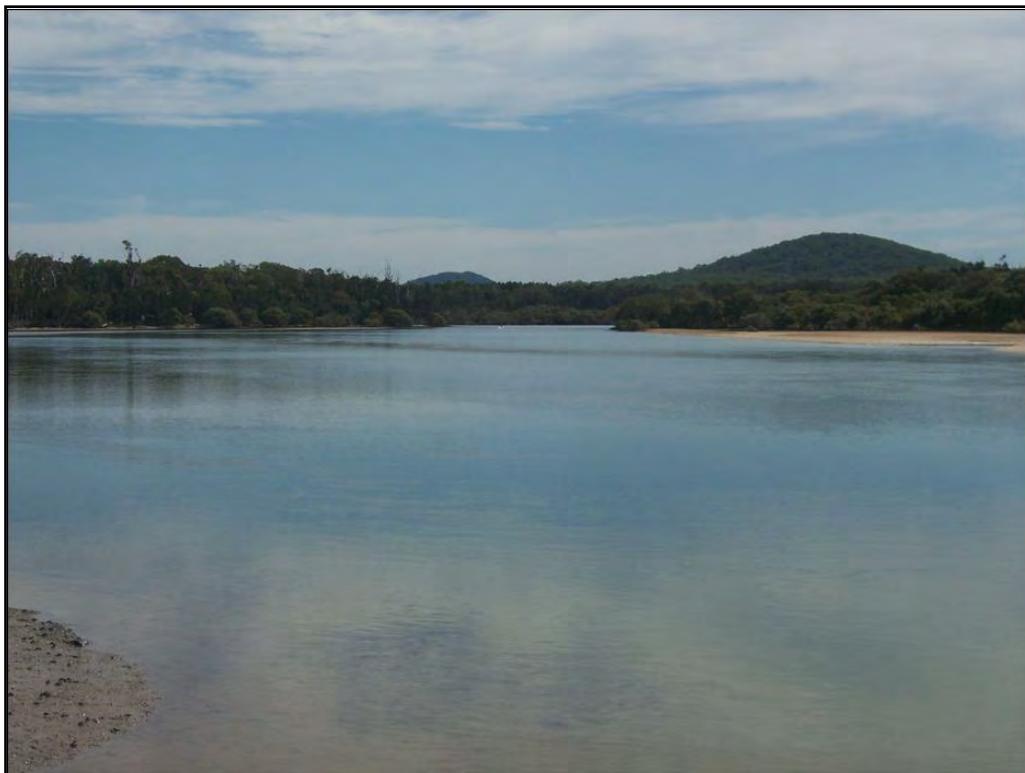
**Plate 3.1** Site CORI1 in the lower Corindi River estuary.

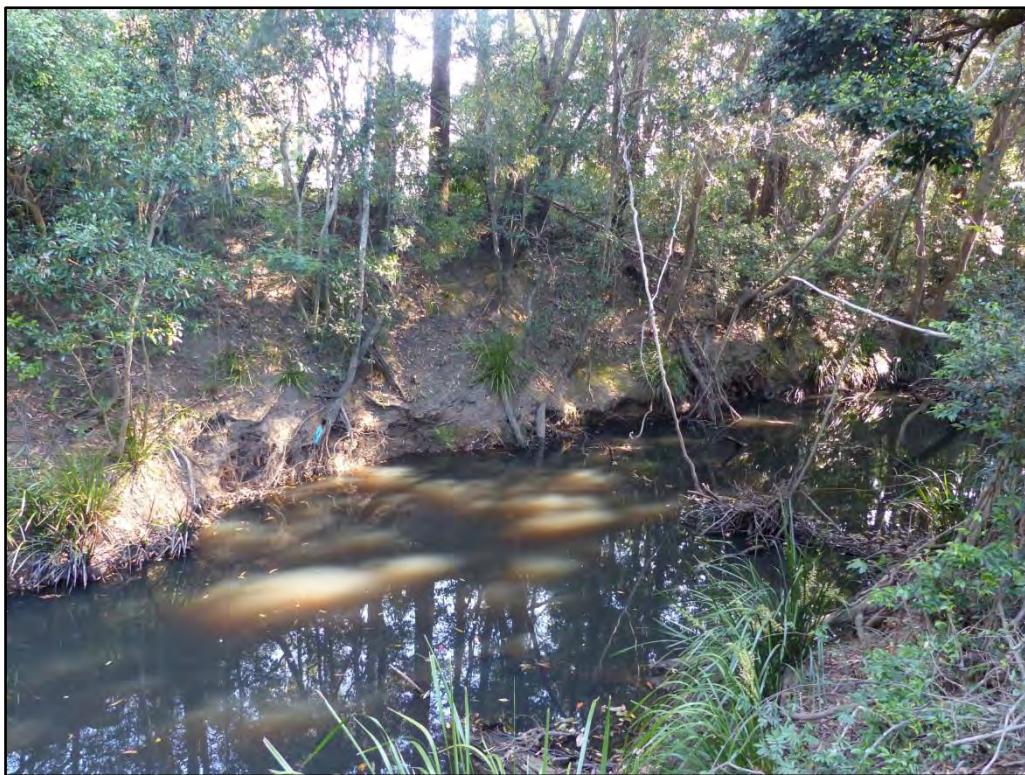
**Plate 3.2** Site CORI4 in the freshwater reach of the Corindi River.

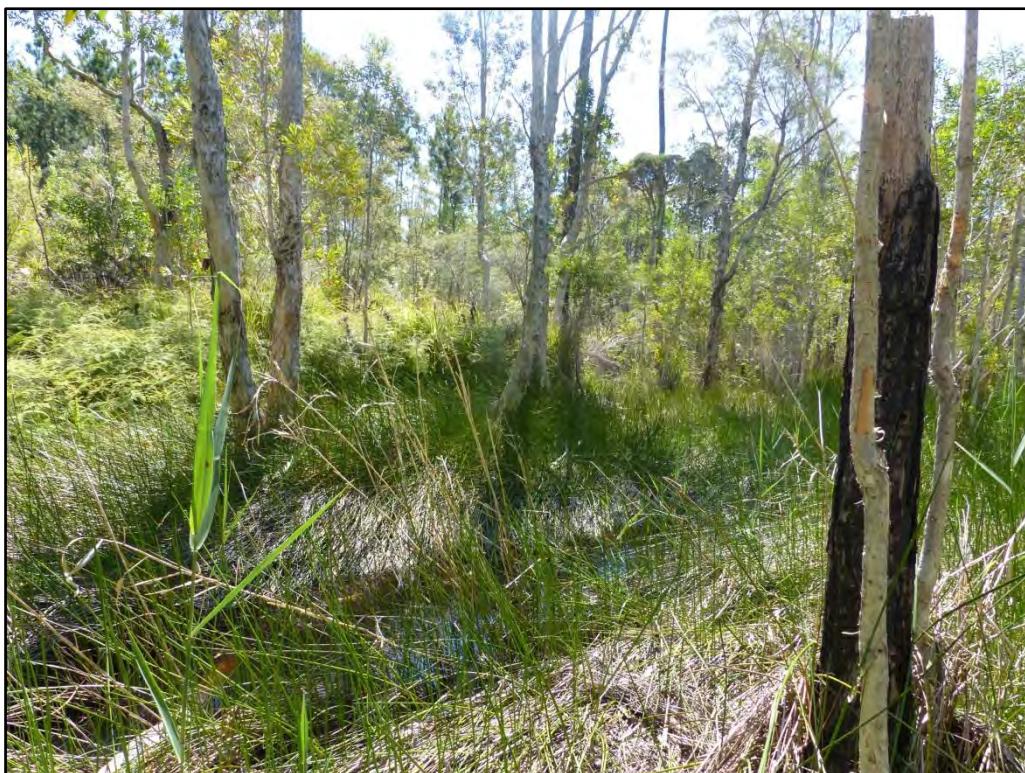
**Plate 3.3** Site SALT3 in the freshwater reaches of Saltwater Creek.

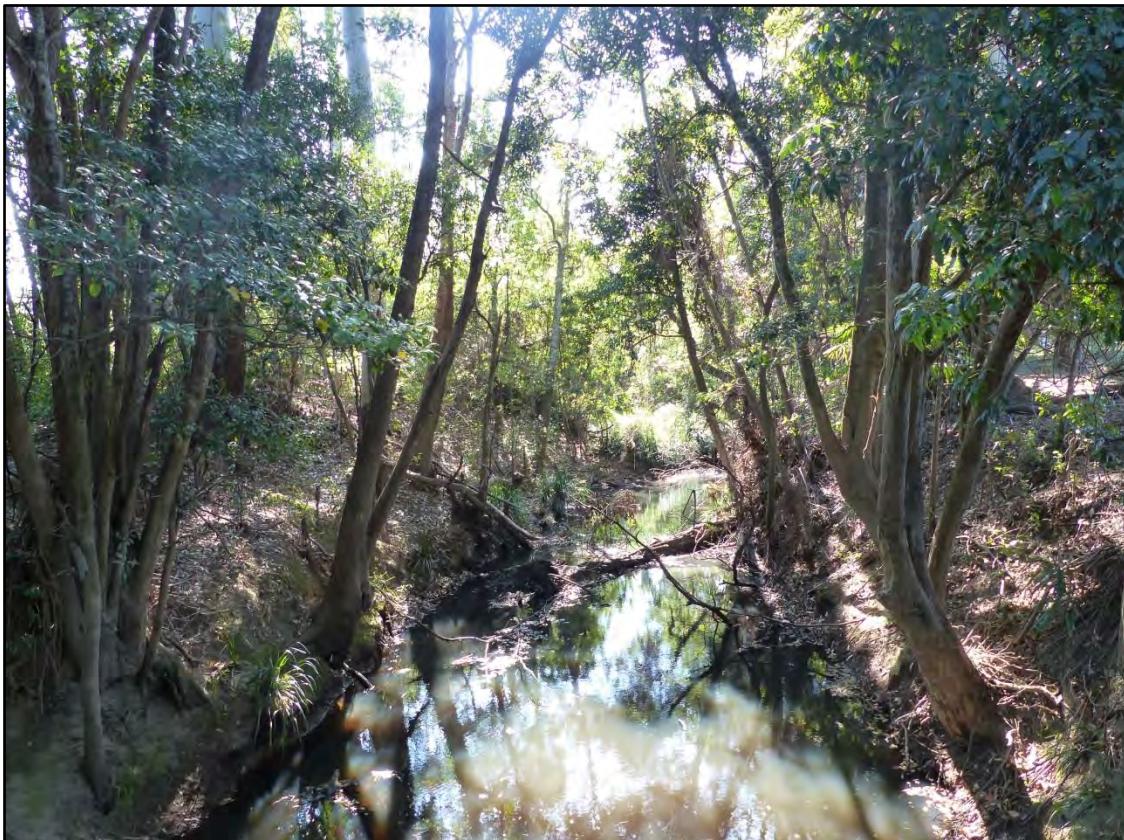
**Plate 3.4** Riparian vegetation at Corindi River #4 was in an average condition. While remnant elements were present in all structural layers, riparian condition could be greatly improved with the strategic phasing out of Camphor Laurel, the removal of other weed species and fencing of the riparian zone.

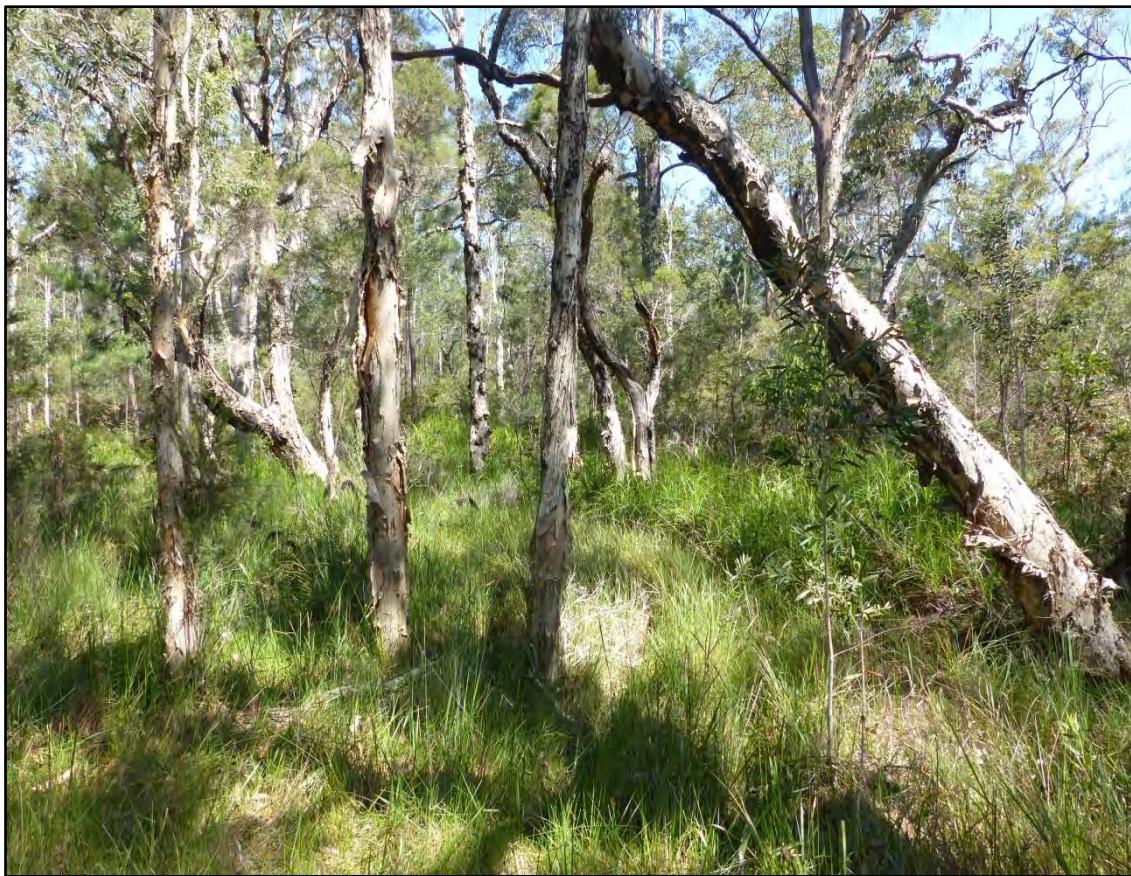
**Plate 3.5** Riparian vegetation at Saltwater Creek #3 was in exceptional condition. Although limited in their presence, several noxious weed species were observed at the northern edge of the site; thus weed control and monitoring would be beneficial to ensure the current exemplary condition was maintained.

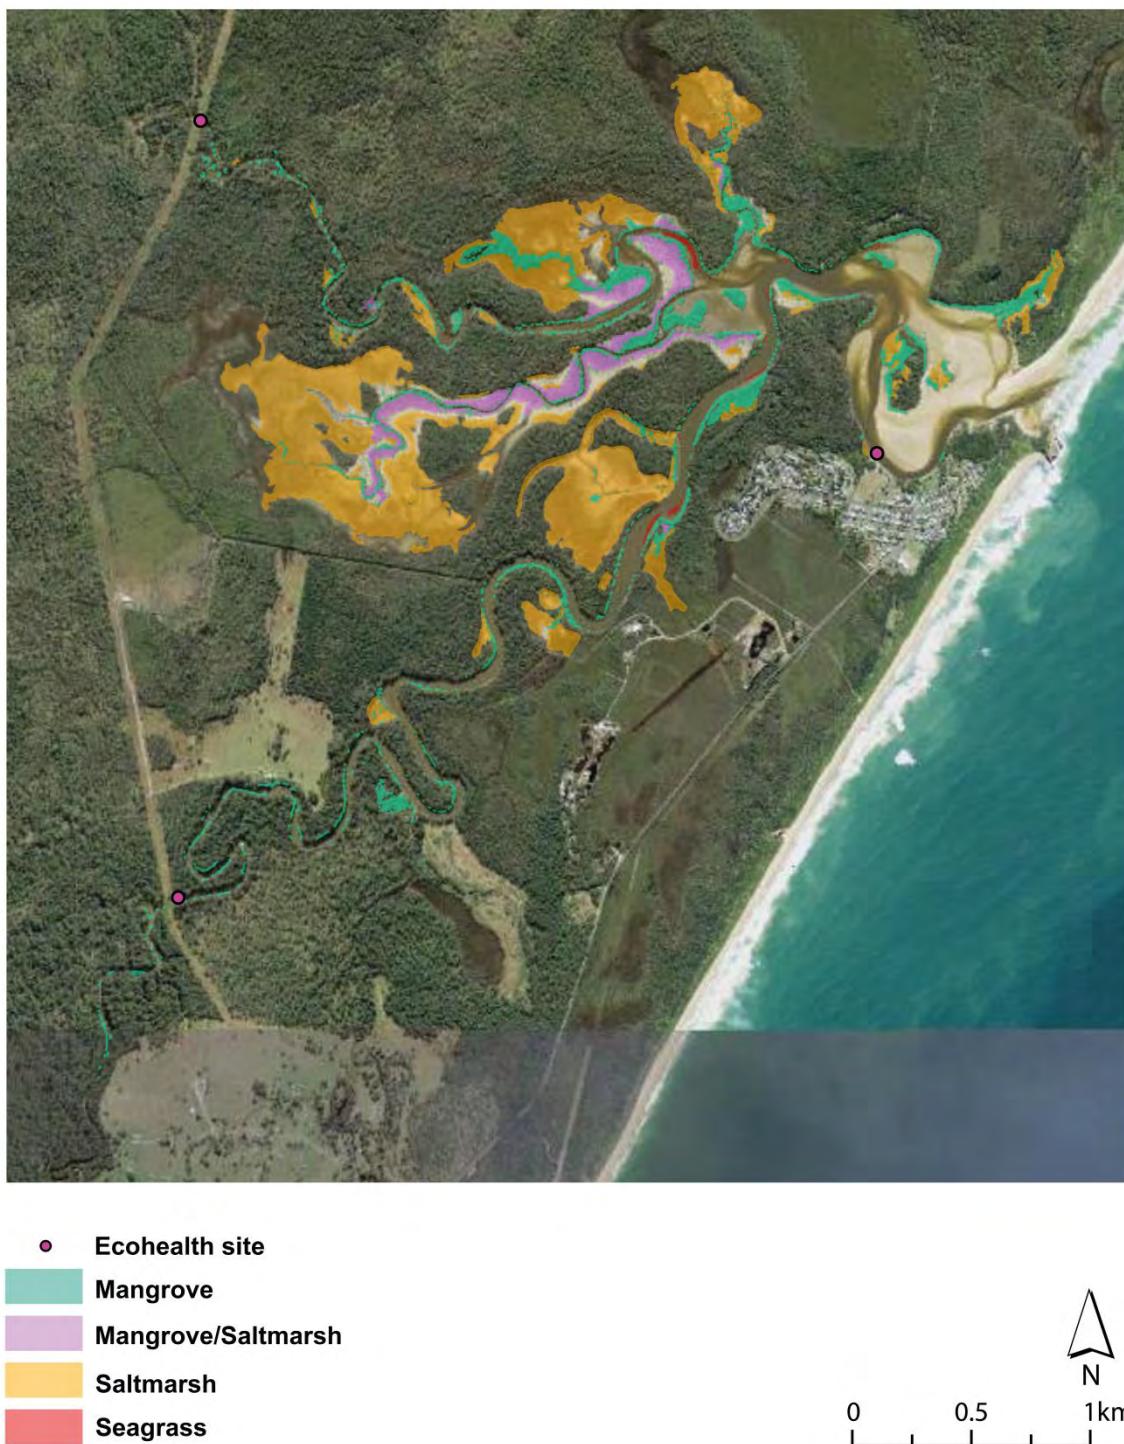
**Figure 3.4** Mangrove, seagrass and saltmarsh habitats in the Corindi River/Saltwater Creek estuary (NSW Department of Industry and Investment – Primary Industries and Energy 2011).

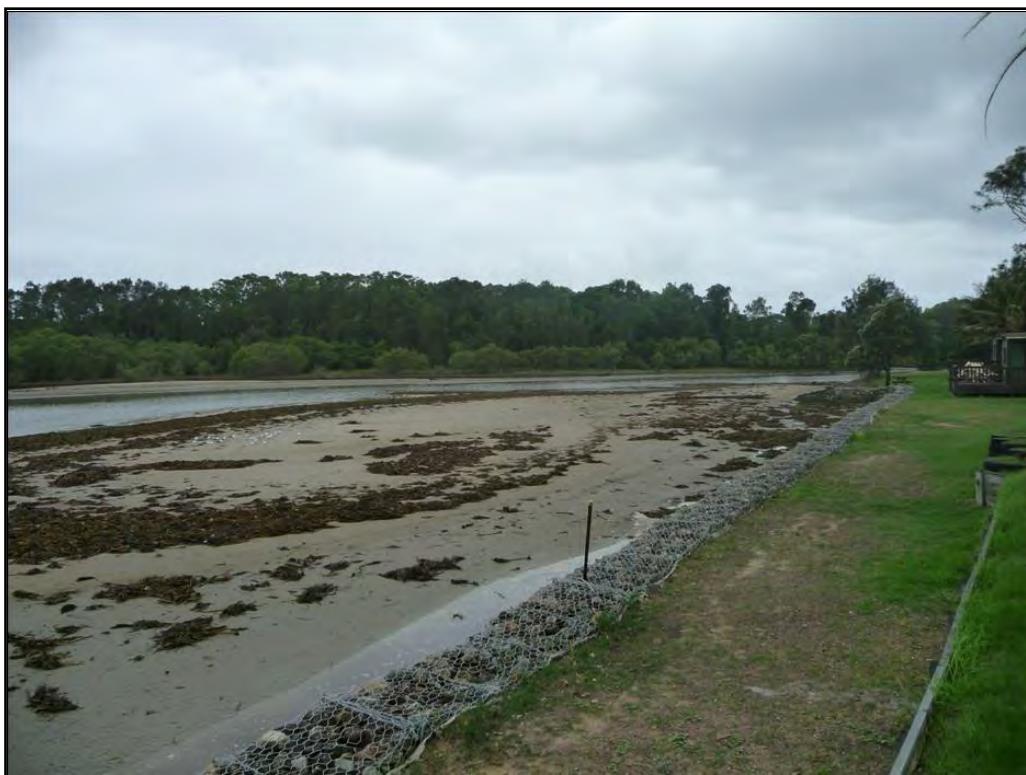
**Plate 3.6** Site ARRA1 in the lagoon at the mouth of Arrawarra Creek.

Two sites were monitored for the Arrawarra Creek subcatchment. Site ARRA1 is the most downstream site located in the tidal lagoon (Plate 3.6). The channel in this reach is defined as planform controlled tidal. The freshwater site ARRA4 is upstream of the tidal limit; it is also close to the Pacific Highway (Plate 3.7). The reach surrounding ARRA4 is defined as swampy meadow, valley fill, sand.

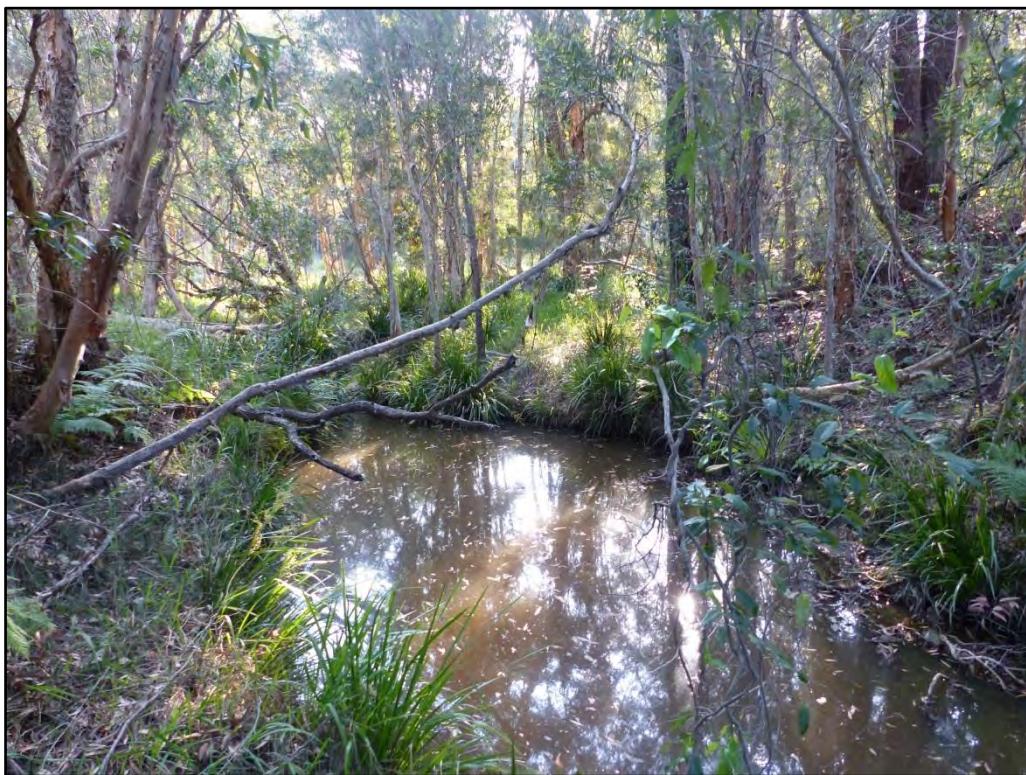
**Plate 3.7** Site ARRA4 in the freshwater reaches of Arrawarra Creek.

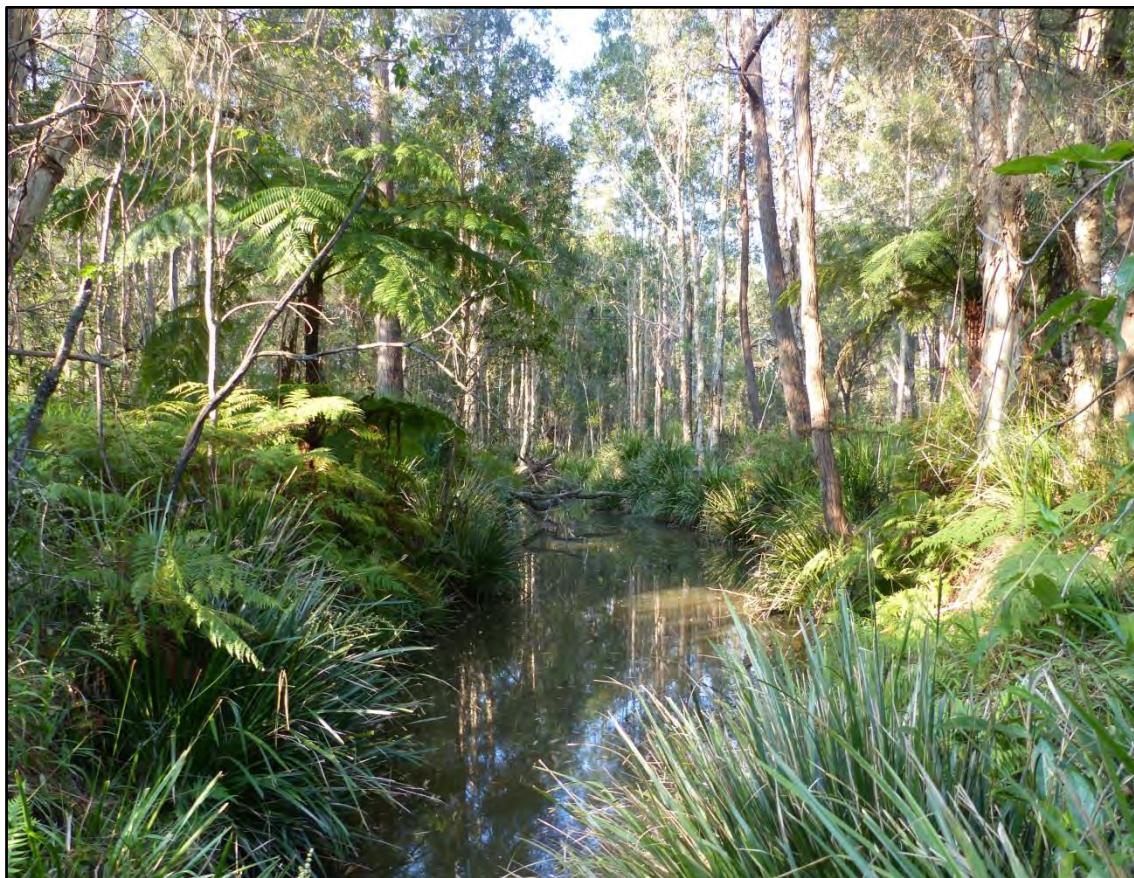
**Plate 3.8** Riparian vegetation at Arrawarra Creek #3 was in exceptional condition. Although limited in their presence, weed control and monitoring would be beneficial to ensure the current exemplary condition was maintained.

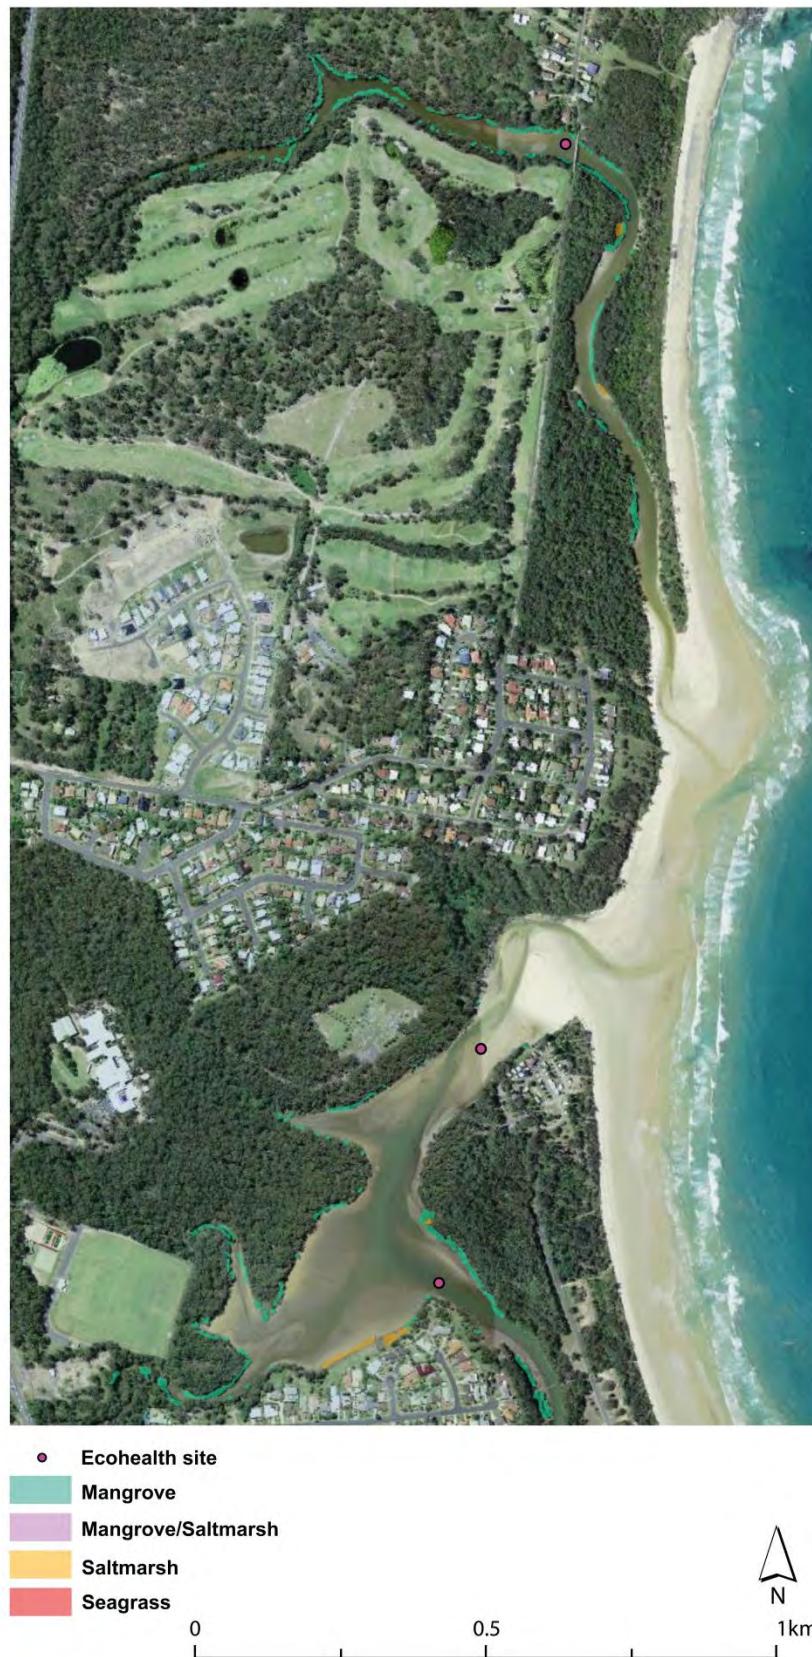
**Figure 3.10** Mangrove, seagrass and saltmarsh habitats in the Darkum Creek estuary (NSW Department of Industry and Investment – Primary Industries and Energy 2011).

Of the 9 Coffs Harbour estuarine systems, Darkum Creek estuary recorded the lowest cover for total estuarine macrophytes (Figure 3.10). Two estuarine vegetation communities were present in the Darkum Creek estuarine system: mangroves were the dominant vegetation community covering 0.007km<sup>2</sup>, with saltmarsh covering less than 0.001km<sup>2</sup>. Saltmarsh was not present in the 1985 estuarine macrophyte survey of Darkum Creek, indicating an expansion in range for saltmarsh. Despite being present in the 1985 estuarine macrophyte survey, no seagrass community was recorded in Darkum estuary in 2011. Therefore, a management priority for estuarine macrophytes in the Darkum estuary is for further research to determine where seagrass has been lost from the estuary and to identify contributing factors. Future investment may include re-establishing seagrass in this estuary once the underlying causes for seagrass loss are better understood.

Total estuarine macrophyte cover in the Darkum Creek estuary has decreased from 1985 (0.023km<sup>2</sup>) to 2011 (0.007km<sup>2</sup>) (Table 3.23). Both mangrove cover and seagrass cover have decreased from 1985 to 2011 (Table 3.23).

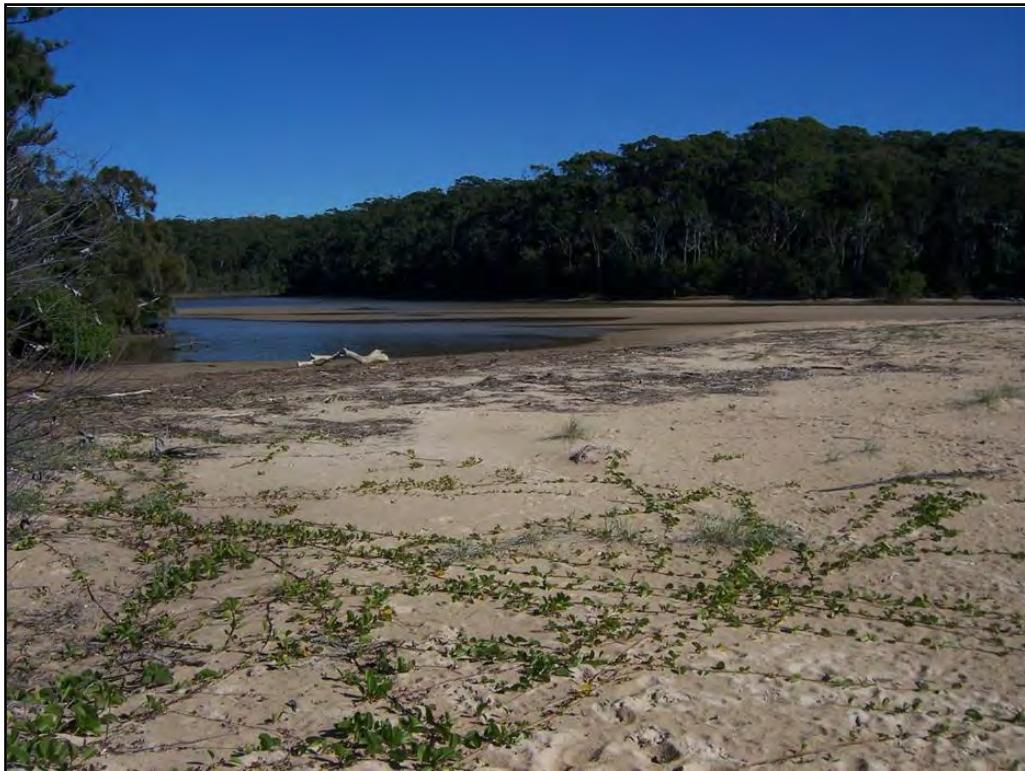
***Plate 3.9*** The site WOOL1 was located in the lagoon, close to the estuary mouth.

Three sites were monitored in Woolgoolga Creek subcatchment in 2015 (Figure 3.12a). WOOL1 was located in the lagoon close to the estuary mouth in a reach defined as planform controlled, tidal (Plate 3.9). WOOL3 was located at the tidal limit, also in a reach defined as planform controlled, tidal (Plate 3.10). WOOL4 was the most upstream site, located in the freshwater zone in a reach defined as confined valley with floodplain pockets, gravel (Plate 3.11).

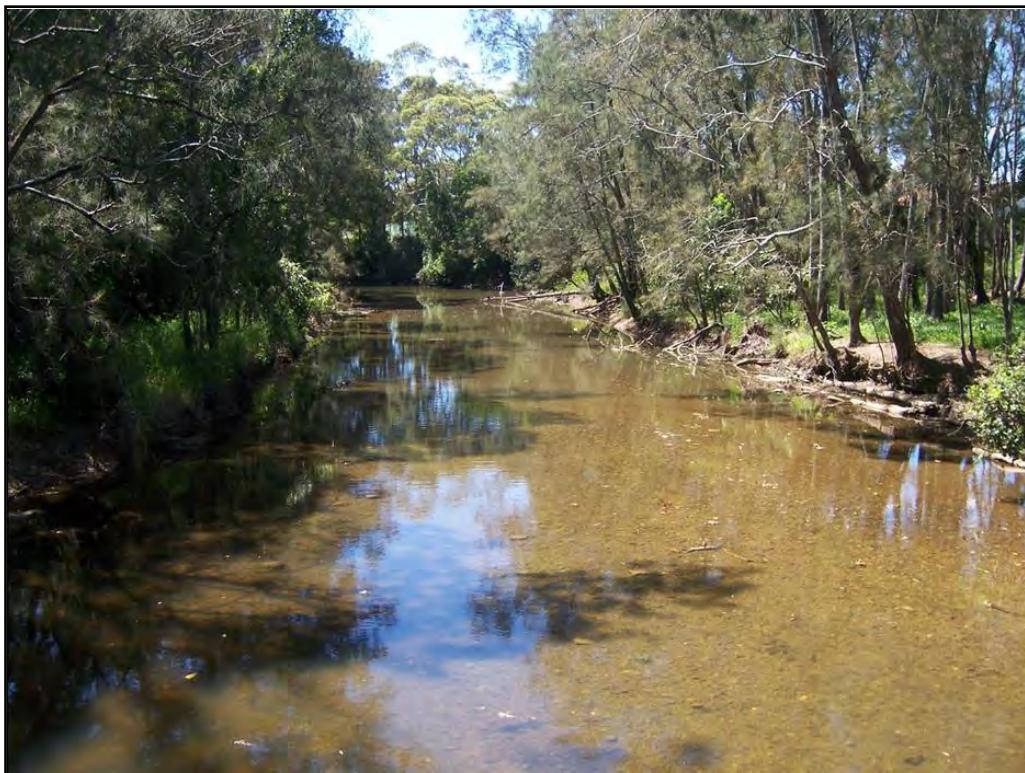
**Plate 3.10** The site WOOL3 was located at the tidal limit in Woolgoolga Lake.

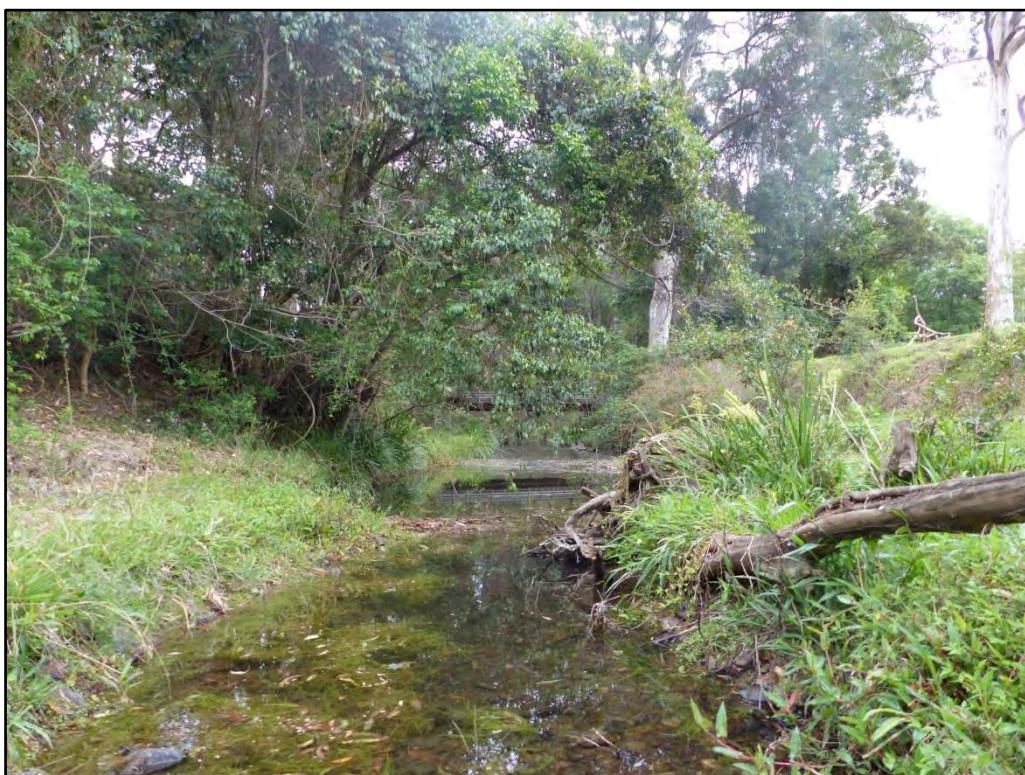
**Plate 3.11** The site WOOL4 was located in the freshwater reach of Woolgoolga Creek.

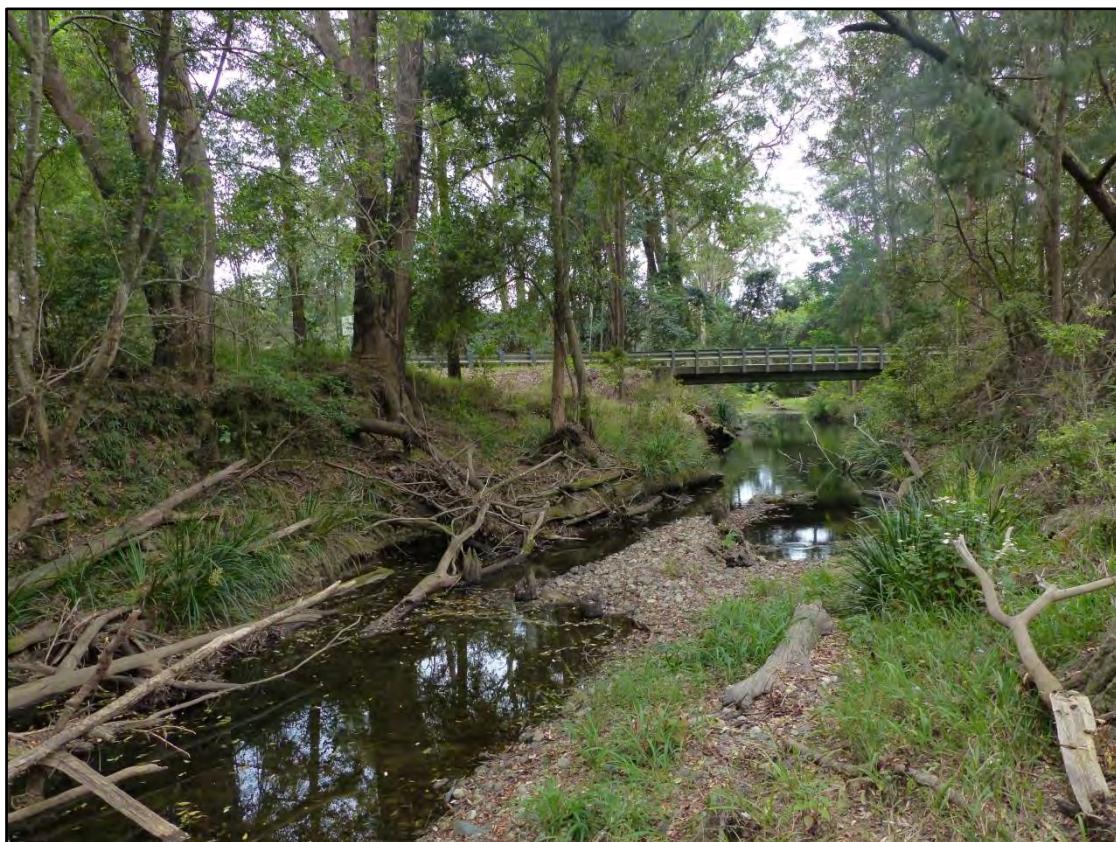
**Plate 3.12** Riparian vegetation at Woolgoolga Creek #4 was in average condition. While remnant sections of the site were representative of the original vegetation community, noxious and environmental weeds, and cleared and unfenced sections of riparian vegetation reduced the final score.

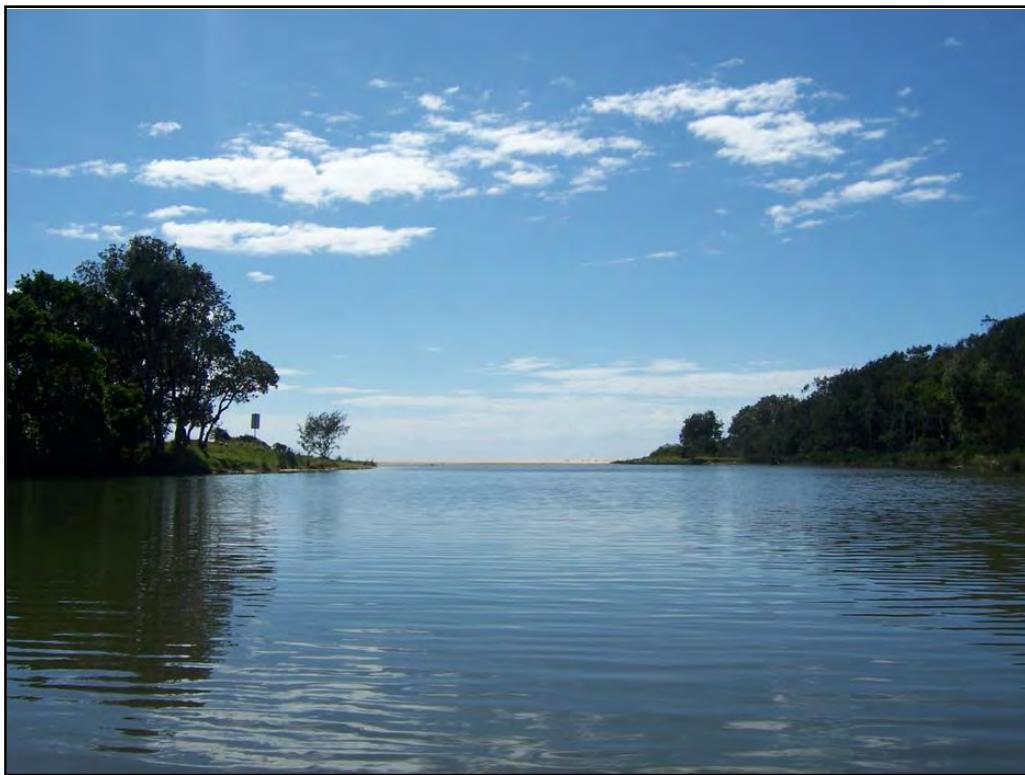
**Plate 3.13** Site HEAR1 is located in an estuarine lagoon near its mouth.

Two sites were located in Hearnes Lake in 2015 (Figure 3.15a). Site HEAR1 was located in the estuarine lagoon close to the mouth of the lake with Double Crossing Creek (Plate 3.13). Site HEAR4 was a new site established in 2015. HEAR4 was the most upstream site, located in a freshwater inflow in a reach defined as a confined valley with floodplain pockets, gravel (Plate 3.14).

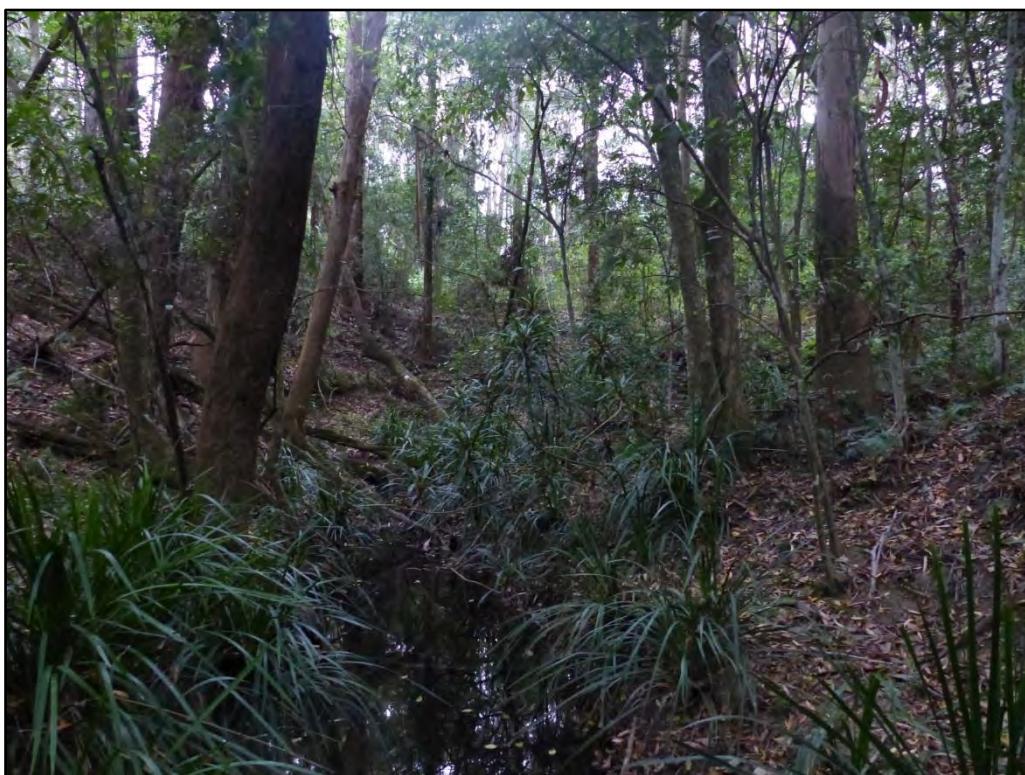
**Plate 3.14** Site HEAR4 is located in the freshwater input to Hearnes Lake.

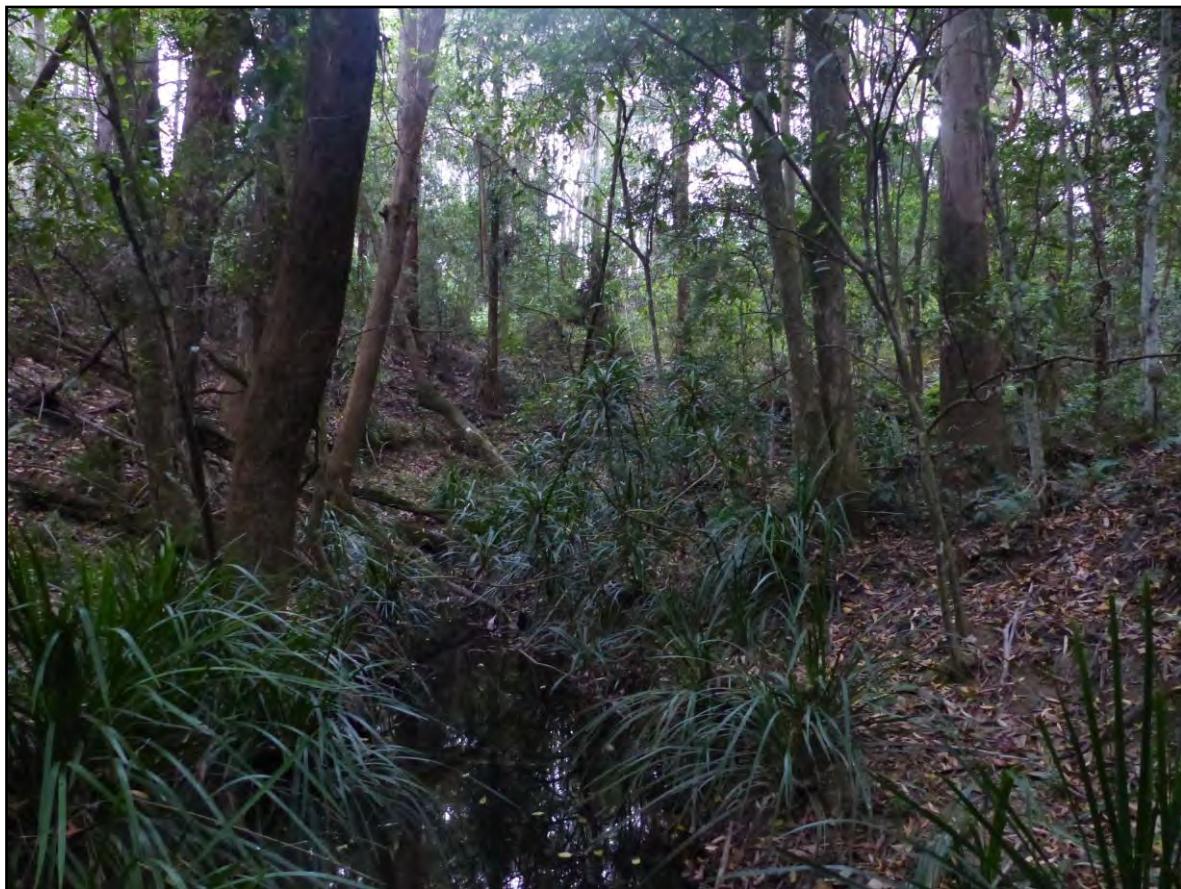
**Plate 3.15** Riparian vegetation at Hearnes Lake #4 was in very good condition, with riparian species representative of the original remnant vegetation community. Lantana remains an issue in the midstorey; riparian condition would improve with the removal of Lantana.

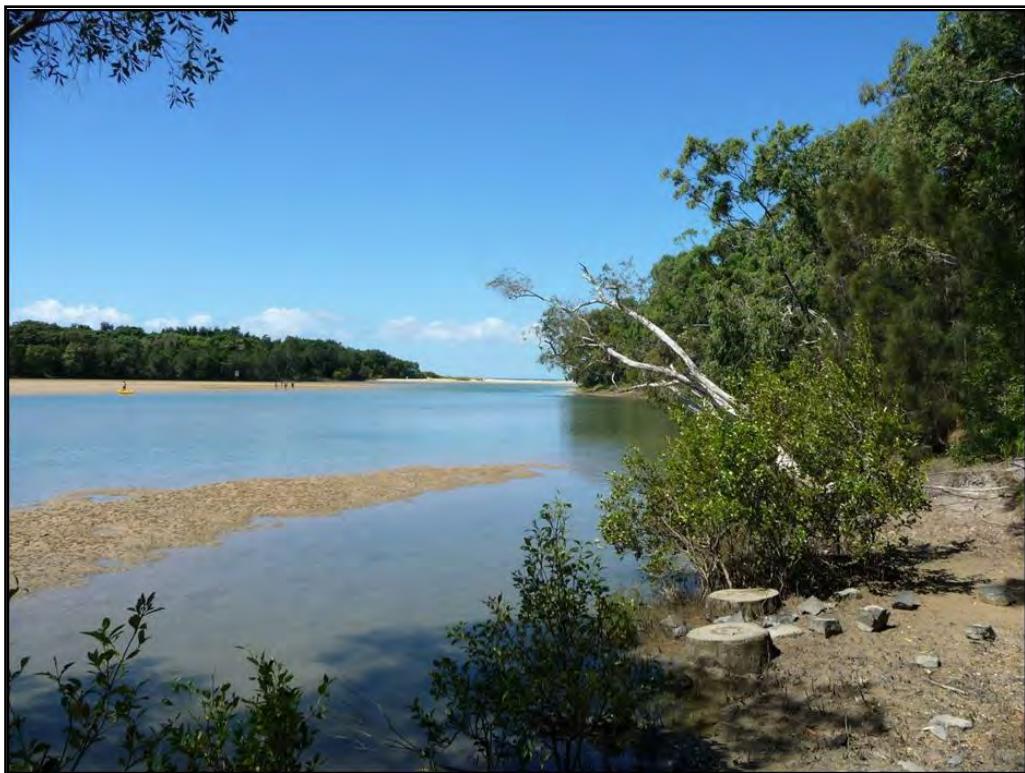
**Plate 3.16** The site MOON1 looking downstream towards the mouth of the Moonee Creek estuary.

Three sites on Moonee Creek were sampled in 2015 (Figure 3.18). Site MOON1 (Plate 3.16) was in the lower estuary in the marine-influence salinity zone (+30ppt). Site MOON3 was located at the tidal limit in a reach defined as laterally unconfined and tidal (Plate 3.17). Site MOON4 was located on a freshwater reach of a major eastern flowing tributary of Moonee Creek (Plate 3.18). The surrounding reach was defined as planform controlled, meandering, fine grained.

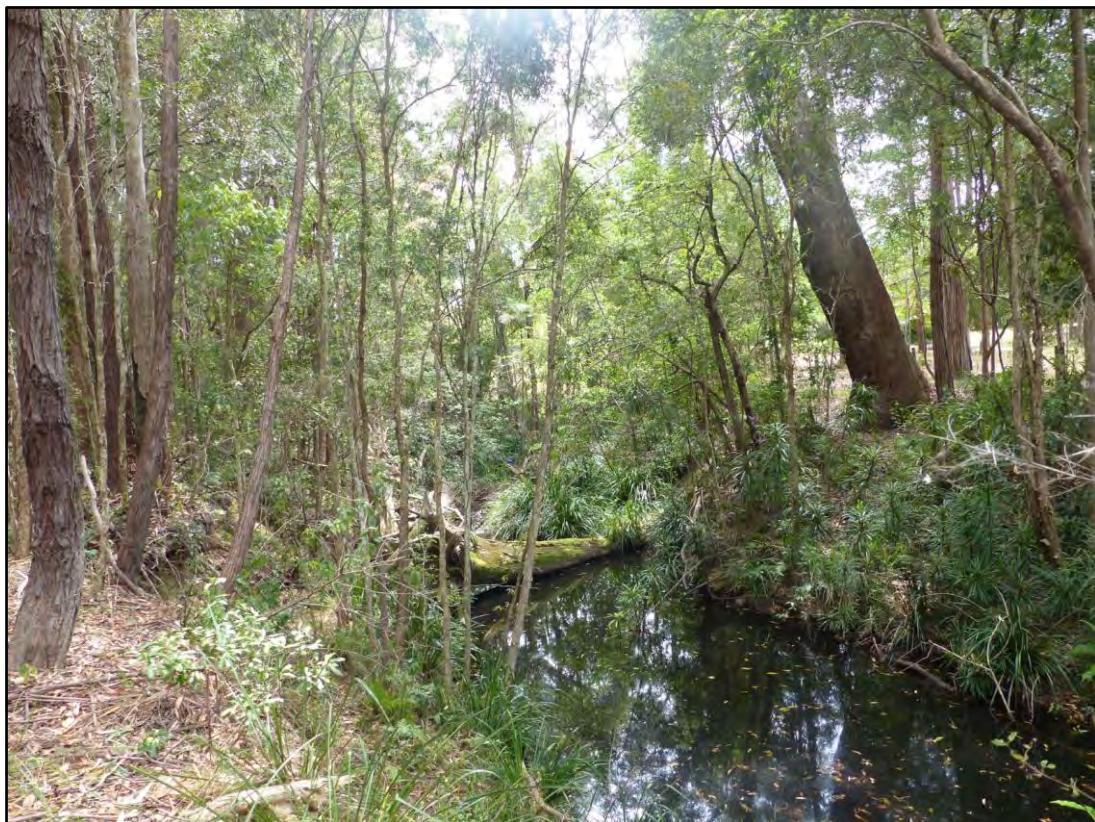
**Plate 3.18** Riparian vegetation at Moonee Creek #4 was in very good condition. Weed removal and monitoring would be beneficial to ensure that the current riparian conditions were maintained.

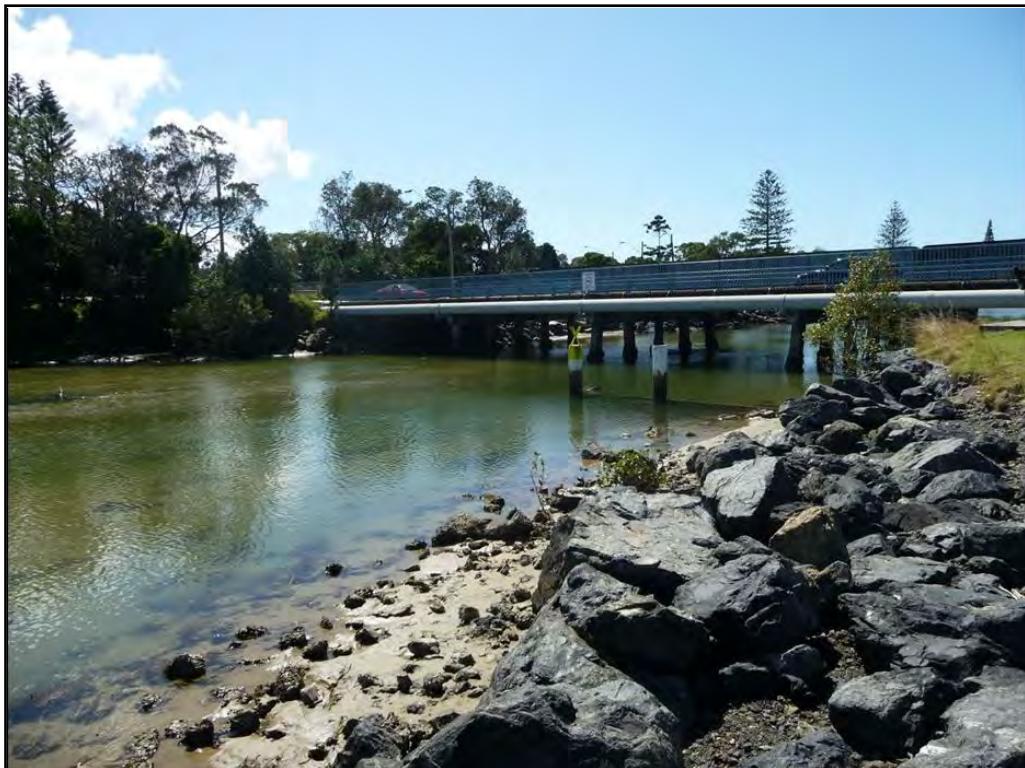
***Plate 3.19*** The site COFFS1 was located in the lower Coffs Creek estuary.

Three sites were monitored in Coffs Creek subcatchment in 2015 (Figure 3.21a). The site COFFS1 was the most downstream site and was located in the lower estuary of Coffs Creek in the marine zone (salinity of +30ppt, Plate 3.19). The site COFFS2 was located in the mid estuary, in an intermediate salinity zone of 15-30ppt. The site COFFS4 was located in the freshwater zone of Coffs Creek in a channel defined as planformed controlled, meandering, fine grained (Plate 3.20).

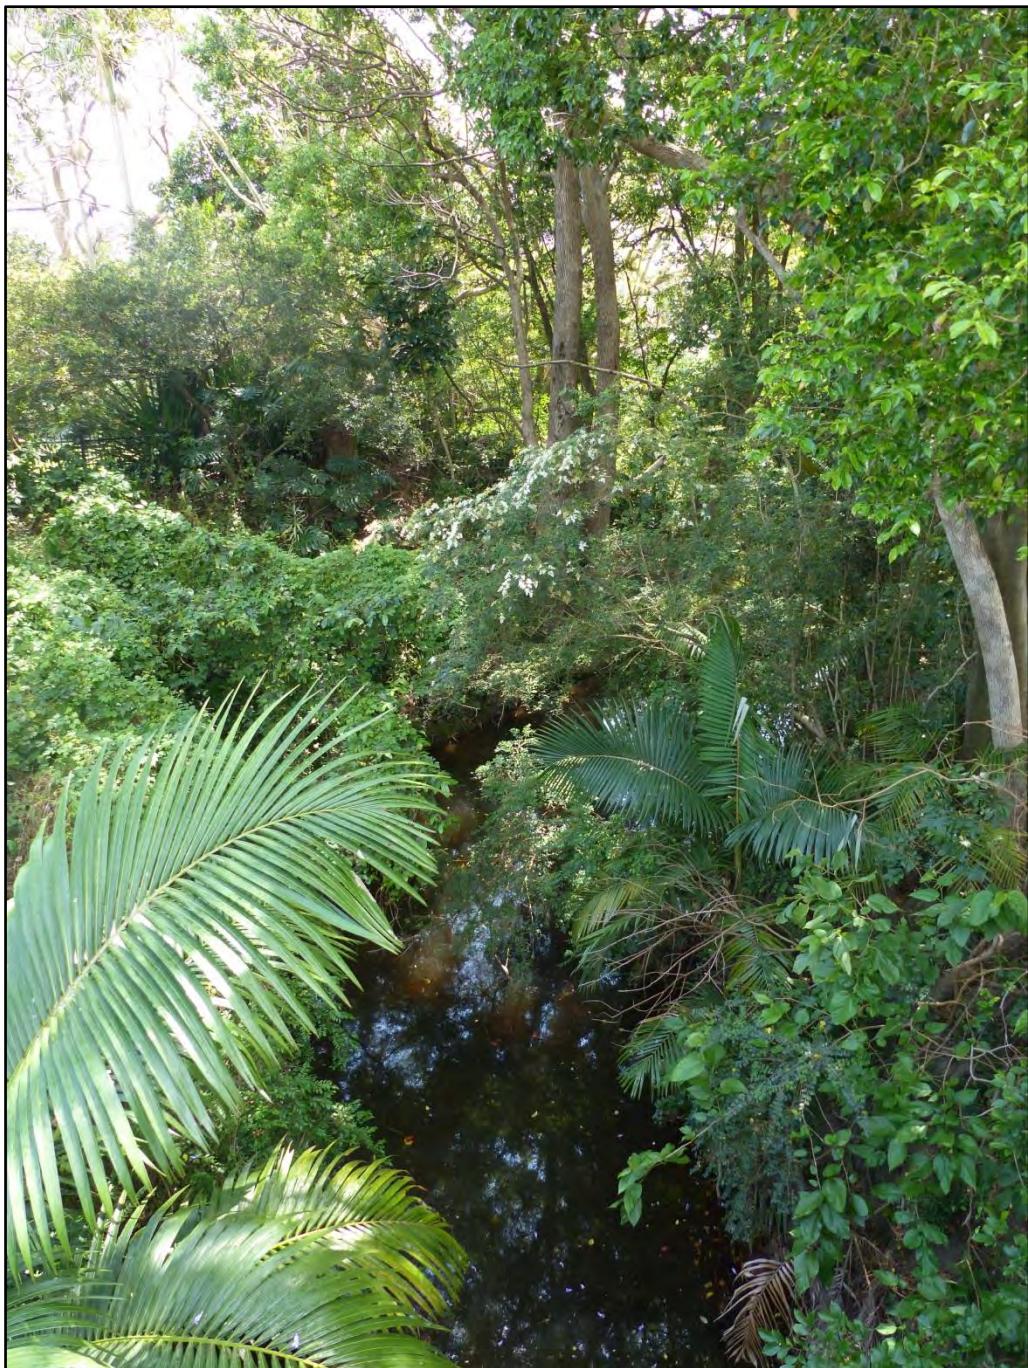
**Plate 3.20** The site COFFS4 was located in the freshwater reaches of Coffs Creek.

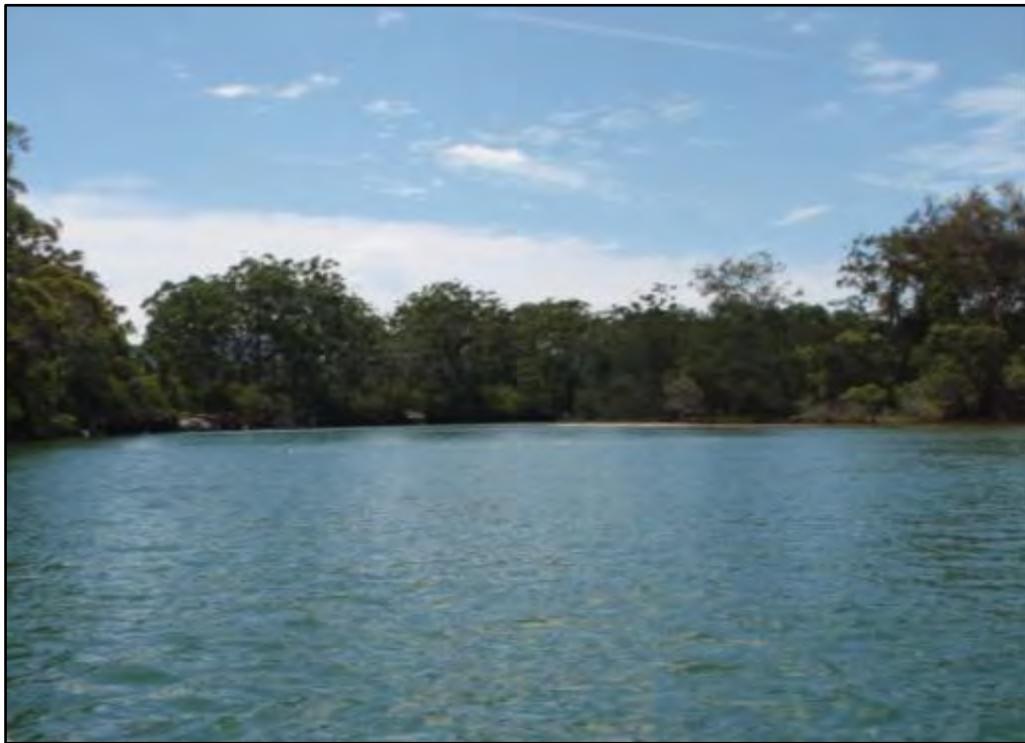
**Plate 3.22** The site BOAM1 looking upstream at the mouth of Boambee Creek.

Three sites were sampled on Boambee Creek in 2015 (Figure 3.24a). The site BOAM1 was located in the lower estuary downstream of the confluence of Boambee and Newports Creeks and is considered to be in the marine zone (salinity +30ppt, Plate 3.22). The site BOAM3 was located at the tidal limit of Boambee Creek in a reach defined as planform controlled, meandering, fine grained. The most upstream site, BOAM4 was in the freshwater reach of Boambee Creek (Plate 3.23). The reach at BOAM4 is also defined as planform controlled, meandering, fine grained.
