# Coffs Harbour Region Ecohealth Project

## 2014-2015

### Assessment of River and Estuarine Condition

**Final Technical Report**

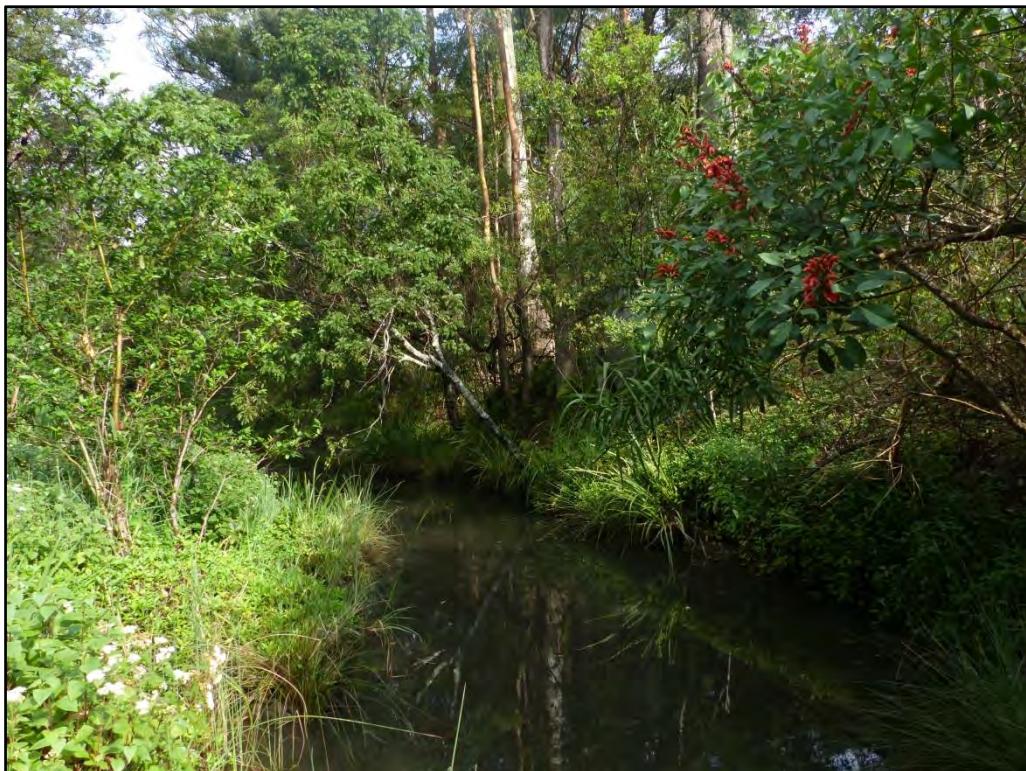
**Plate 3.23** The site BOAM4 in the freshwater reach of Boambee Creek.

Three sites were sampled on Boambee Creek in 2015 (Figure 3.24a). The site BOAM1 was located in the lower estuary downstream of the confluence of Boambee and Newports Creeks and is considered to be in the marine zone (salinity +30ppt, Plate 3.22). The site BOAM3 was located at the tidal limit of Boambee Creek in a reach defined as planform controlled, meandering, fine grained. The most upstream site, BOAM4 was in the freshwater reach of Boambee Creek (Plate 3.23). The reach at BOAM4 is also defined as planform controlled, meandering, fine grained.

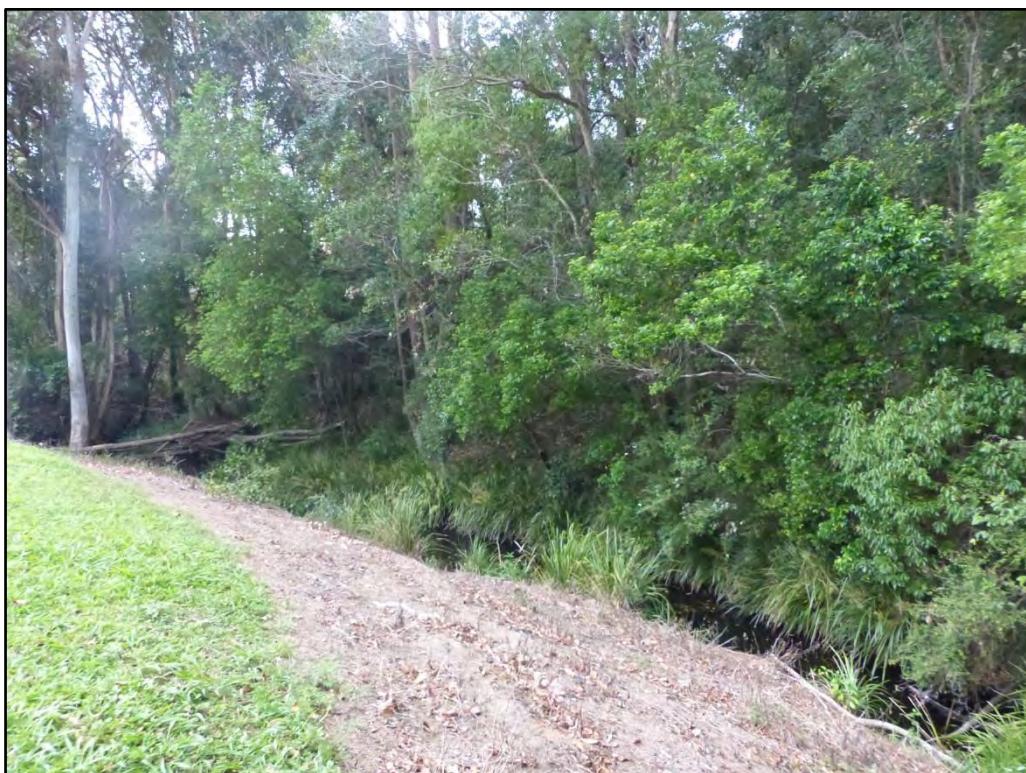
**Plate 3.24** The site NEW3 in the freshwater reach of Newports Creek.

Two sites were sampled on Newports Creek in 2015. Site NEW2 was at the tidal limit of Newports Creek and is defined as planform controlled, tidal. Site NEW3 is the most upstream site on Newports Creek, located in the freshwater reach (Plate 3.24). The channel at NEW3 is defined as planform controlled, low sinuosity, sand.

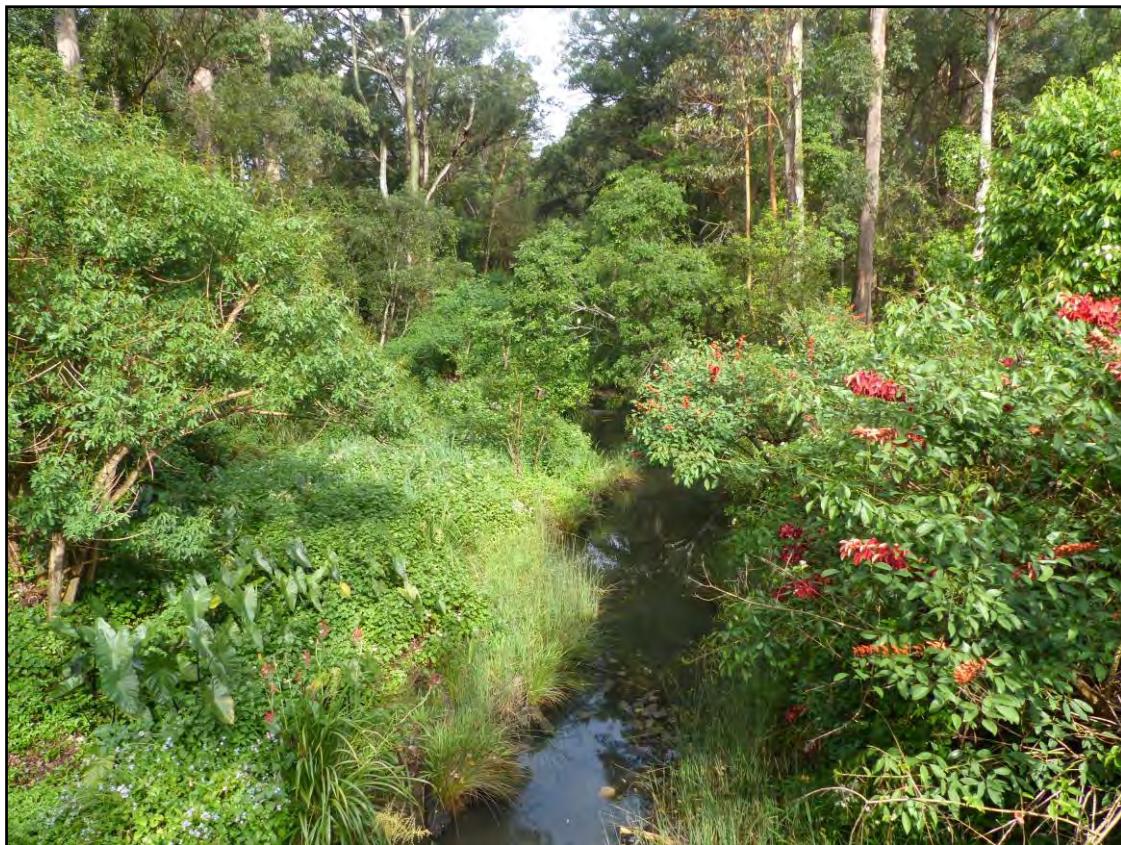
**Plate 3.25** Riparian vegetation at Boambee Creek #4 was in fair condition. Remnant elements were present in all structural layers. However, riparian condition could be improved greatly with the strategic phasing out of Camphor Laurel, and the removal and monitoring of other weed species. Native plantings would improve riparian condition at this site, particularly in cleared weedy sections.

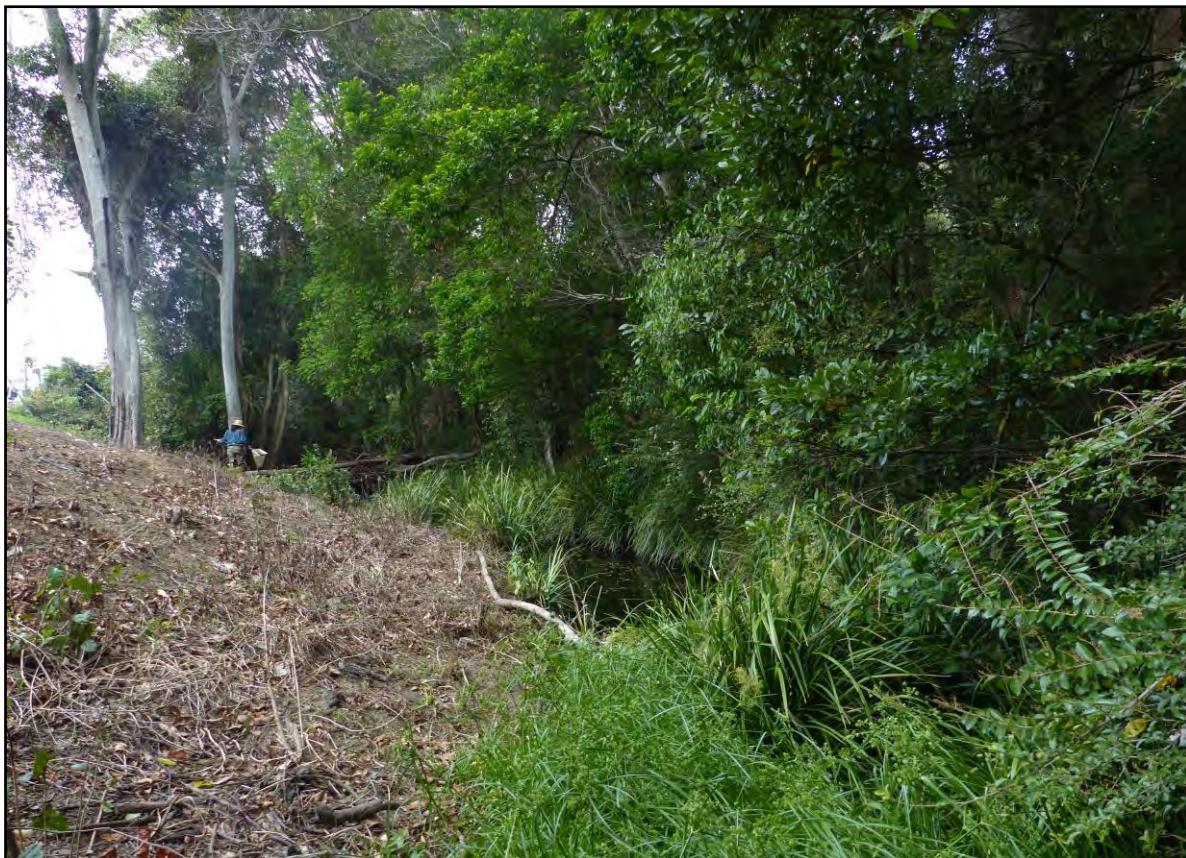
**Plate 3.26** Riparian vegetation at Newports Creek #3 was in fair condition. While native species representative of the original vegetation community were present, they were outweighed at most structural levels by both noxious and environmental weed species. The strategic phasing out of Camphor Laurel, removal and monitoring of other weed species in addition to native plantings would improve riparian condition at this site.

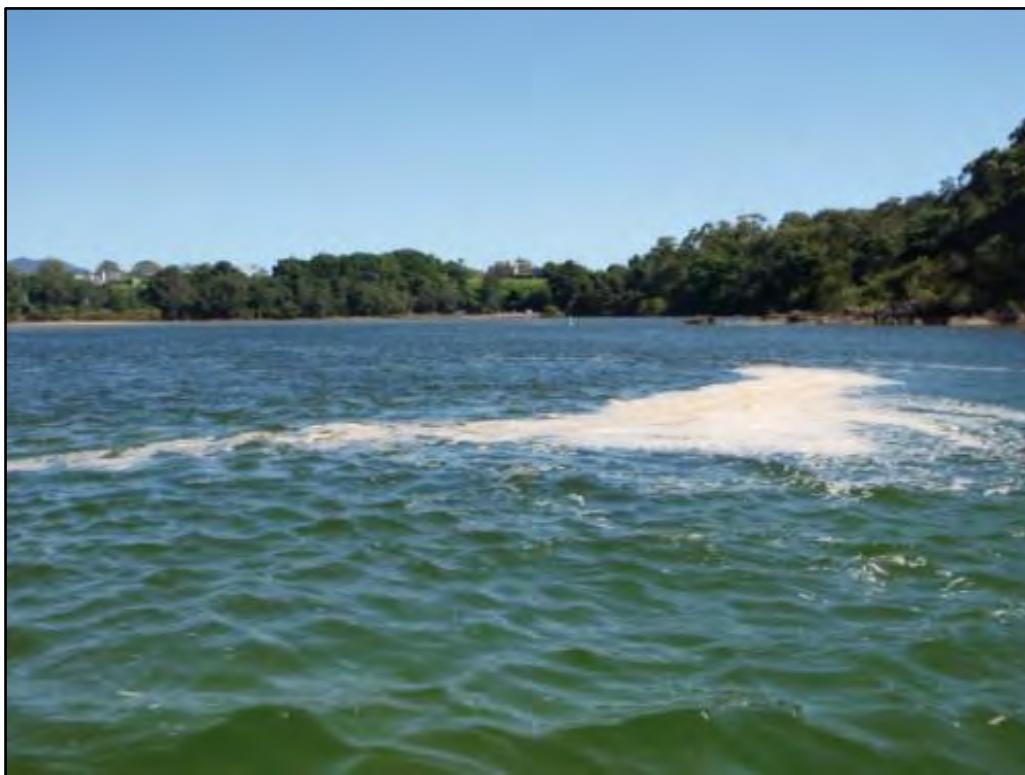
***Plate 3.27 The site BONV1 was near the mouth of the Bonville Creek estuary.***

Three sites on Bonville Creek were sampled in 2015 (Figure 3.27a). The most downstream site was BONV1 in the lower estuary downstream of the confluence with Pine Creek (Plate 3.27). The site was in the marine influence zone (salinity +30ppt) and the channel is defined as laterally unconfined tidal. The site BONV3 is at the tidal limit in Bonville Creek and the surrounding channel is defined as laterally unconfined tidal. The most upstream site, BONV4 (Plate 3.28), was located in the freshwater reaches of Bonville Creek, and the channel was defined as planform controlled, meandering, fine grained.

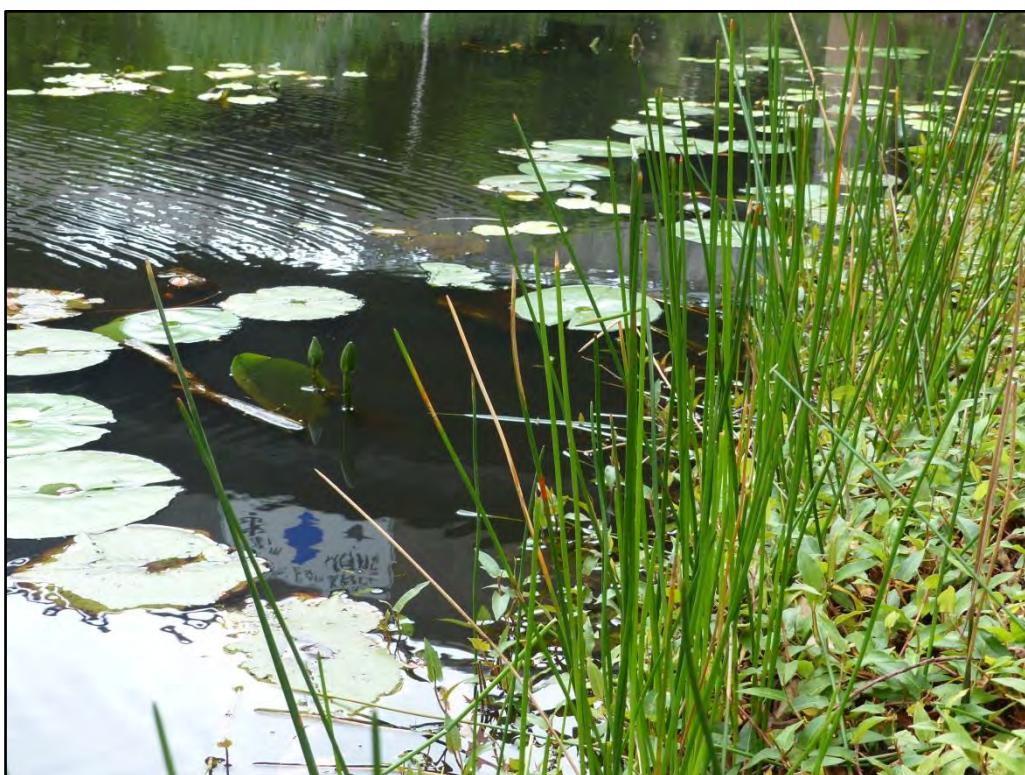
**Plate 3.29** The site PINE3 was in the tidal limit of Pine Creek.

Two sites were monitored on Pine Creek in 2015. The most downstream site was PINE2, located at the tidal limit in Pine Creek. The channel is defined as planform controlled, meandering, fine grained. The most upstream site on Pine Creek was PINE3, located on the freshwater reaches (Plate 3.29). The channel surrounding PINE3 is also defined as planform controlled, meandering, fine grained.

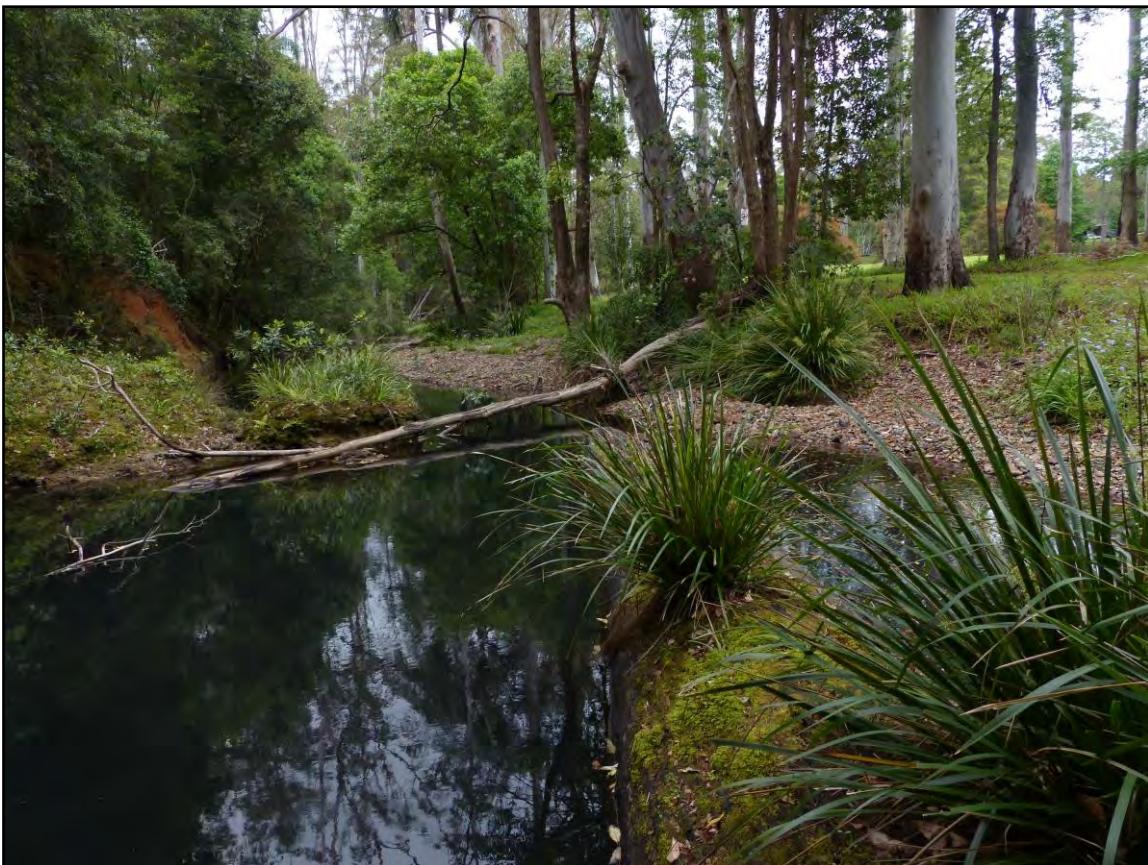
**Plate 3.30** Riparian vegetation at Bonville Creek #4 was in fair condition. While remnant elements representative of the original vegetation community were present in all structural layers, noxious and environmental weeds in addition to unfenced sections of riparian vegetation reduced the final score.

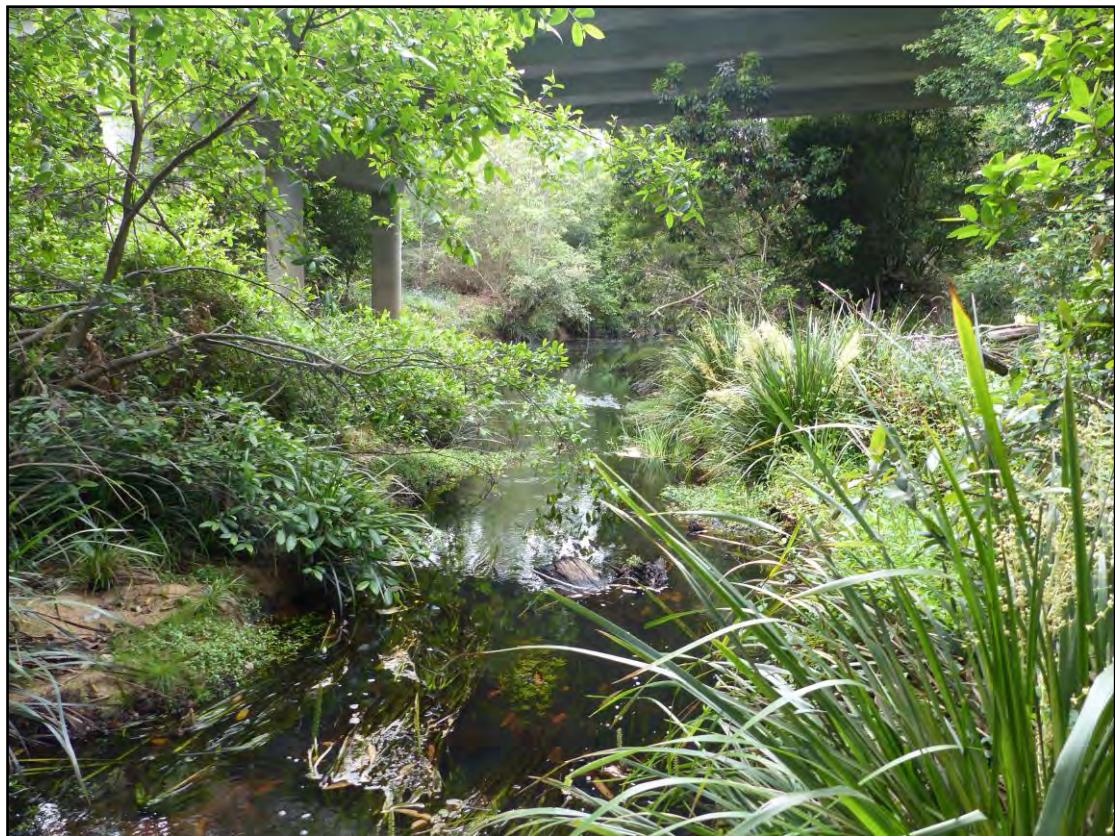
**Plate 3.31** Riparian vegetation at Pine Creek #3 was in fair condition. Remnant elements were present in all structural layers. However, riparian condition could be improved greatly with the removal and monitoring of Lantana and Cabomba weed species. Additional native plantings in combination with complete riparian fencing would continue to improve riparian condition at this site.
