Coffs Harbour City Council

Hydrocarbon Impacted Groundwater, Coramba, NSW

Groundwater Management Plan

February 2017

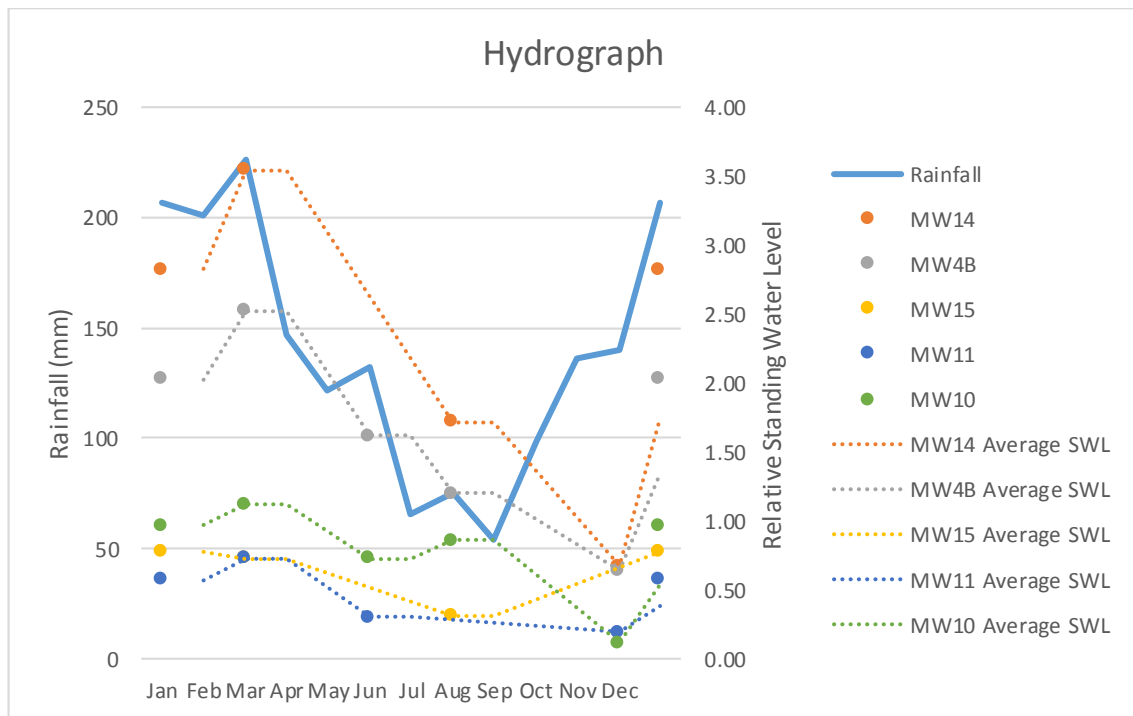
Figure 4-1 Hydrograph showing relative standing water levels in each monitoring well (using available data from 2006-2015) and average monthly rainfall data (1981-2016)

GHD prepared a hydrograph from available monitoring data from 2006 to 2015 and utilising available rainfall data¹ to assess the relationship between rainfall and groundwater levels at the dates of historical monitoring. Since two historical monitoring events were undertaken in March, the standing water levels (SWL) for these two events were averaged. The hydrograph is presented Figure 4-1. Results show that the highest rainfall for the area typically occurs in March, which corresponds to the highest groundwater level, based on limited historical groundwater monitoring events. This indicates that groundwater levels generally correspond to rainfall with minimal lag time.

Groundwater sampling is to be undertaken annually. In order to determine when the sampling events should be undertaken, GHD prepared a hydrograph, which is presented in Section 4.21. Based on the hydrograph, it is recommended to undertake the monitoring in March (commencing in 2017) to capture a representative wet weather (high groundwater level) monitoring round. Historic data indicates March as the time when the highest SWLs are generally recorded and is likely to represent the highest groundwater CoPC concentrations.

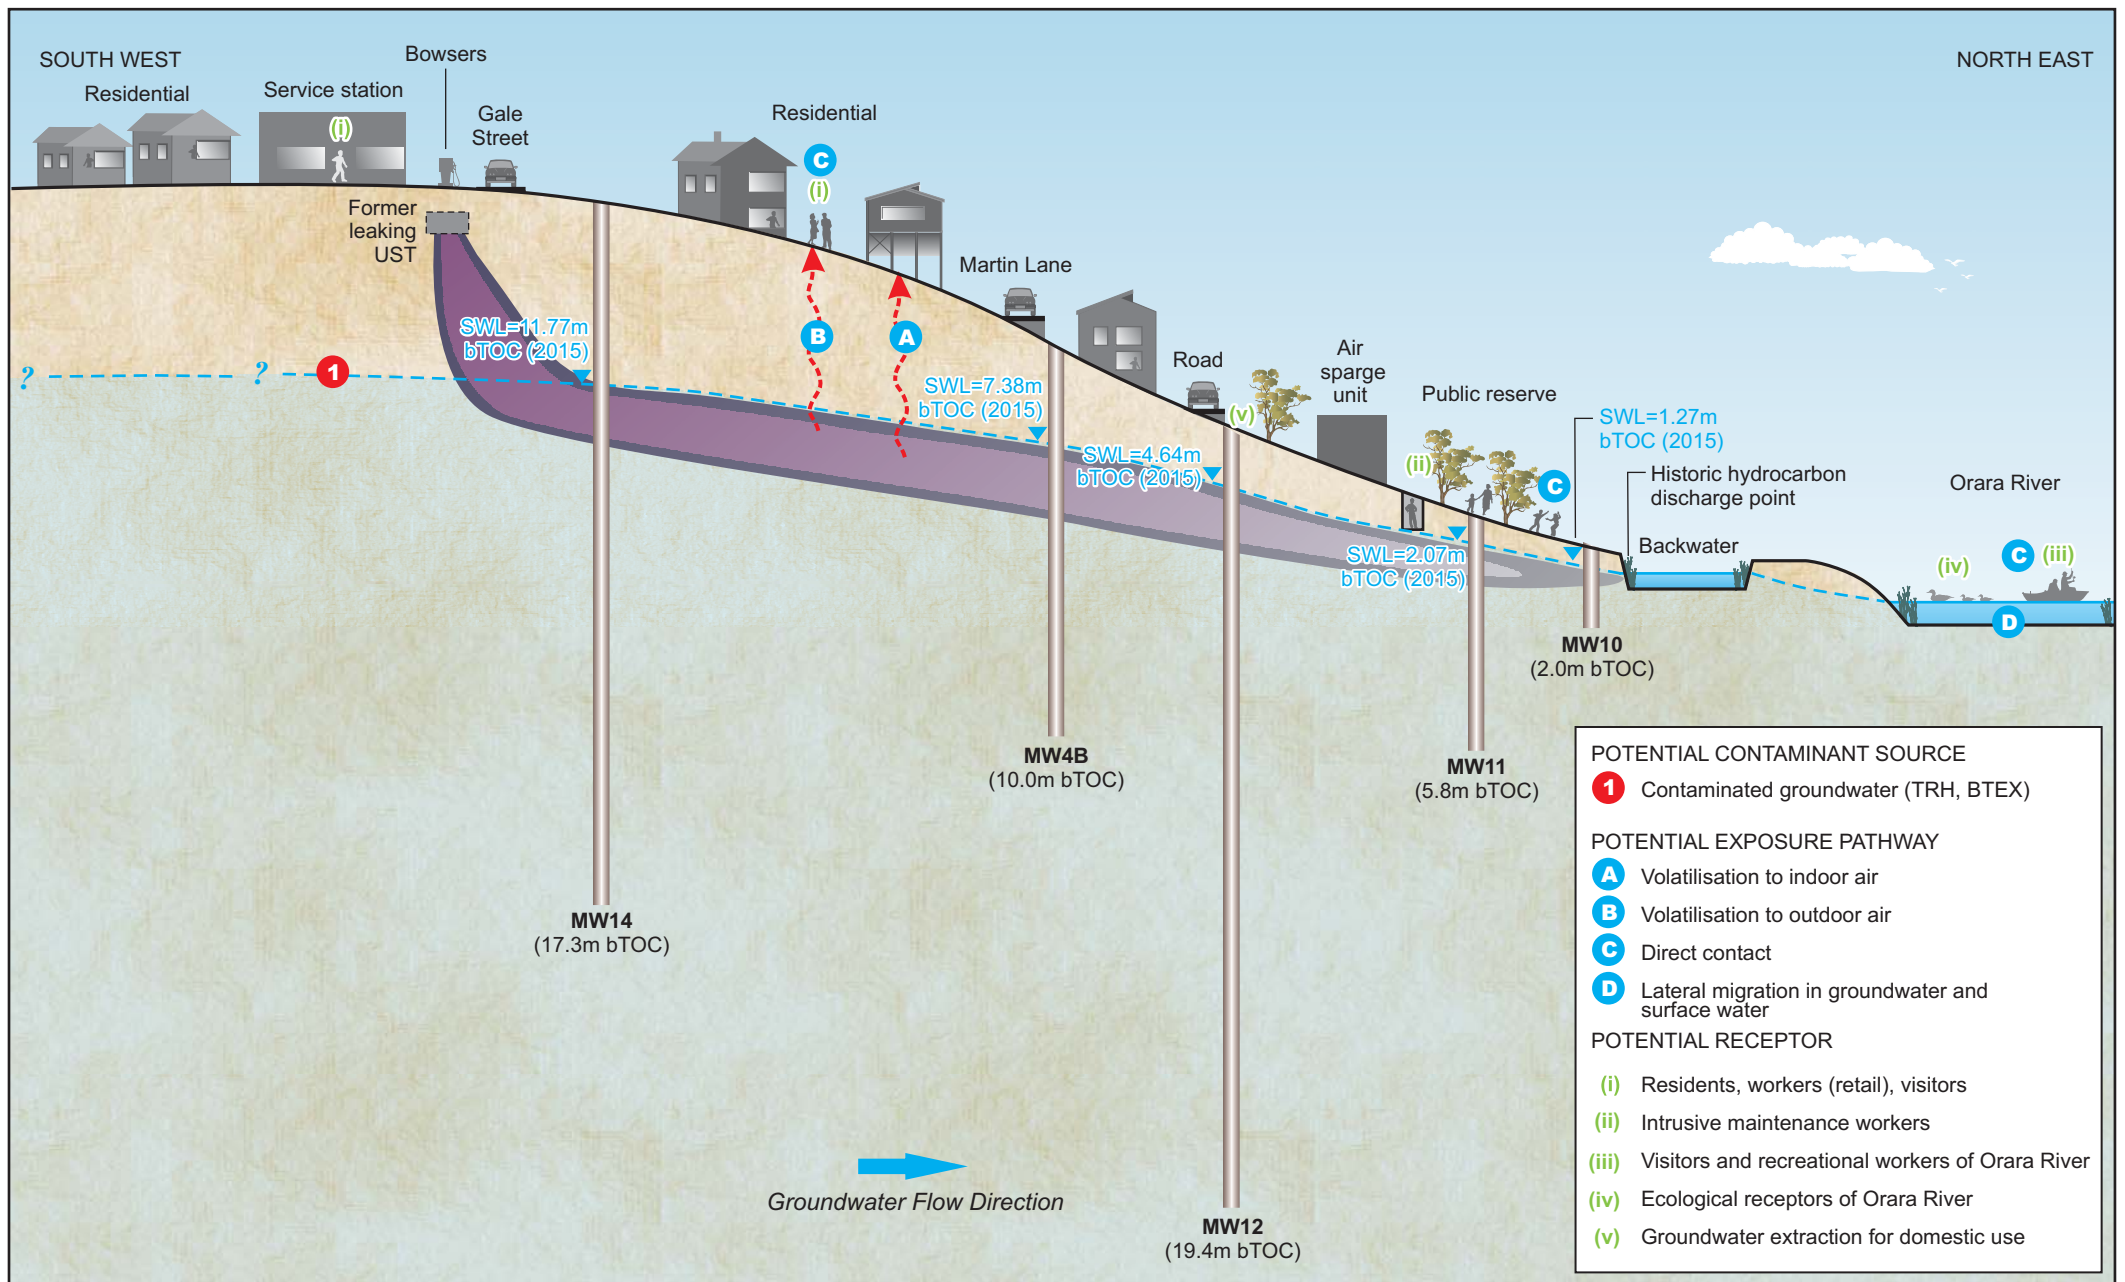
Conceptual diagram only -
not to scale

The presence of TRH and BTEX concentrations historically exceeding guideline levels in a number of wells throughout the site is due to a historical leak in a UST from the up gradient service station. Since the removal of this UST contaminant concentrations have generally been decreasing, however source-pathway-receptor linkages are still present. The CSM is presented in Table 5-1 and Figure 5-1 and refers to impacted groundwater only.

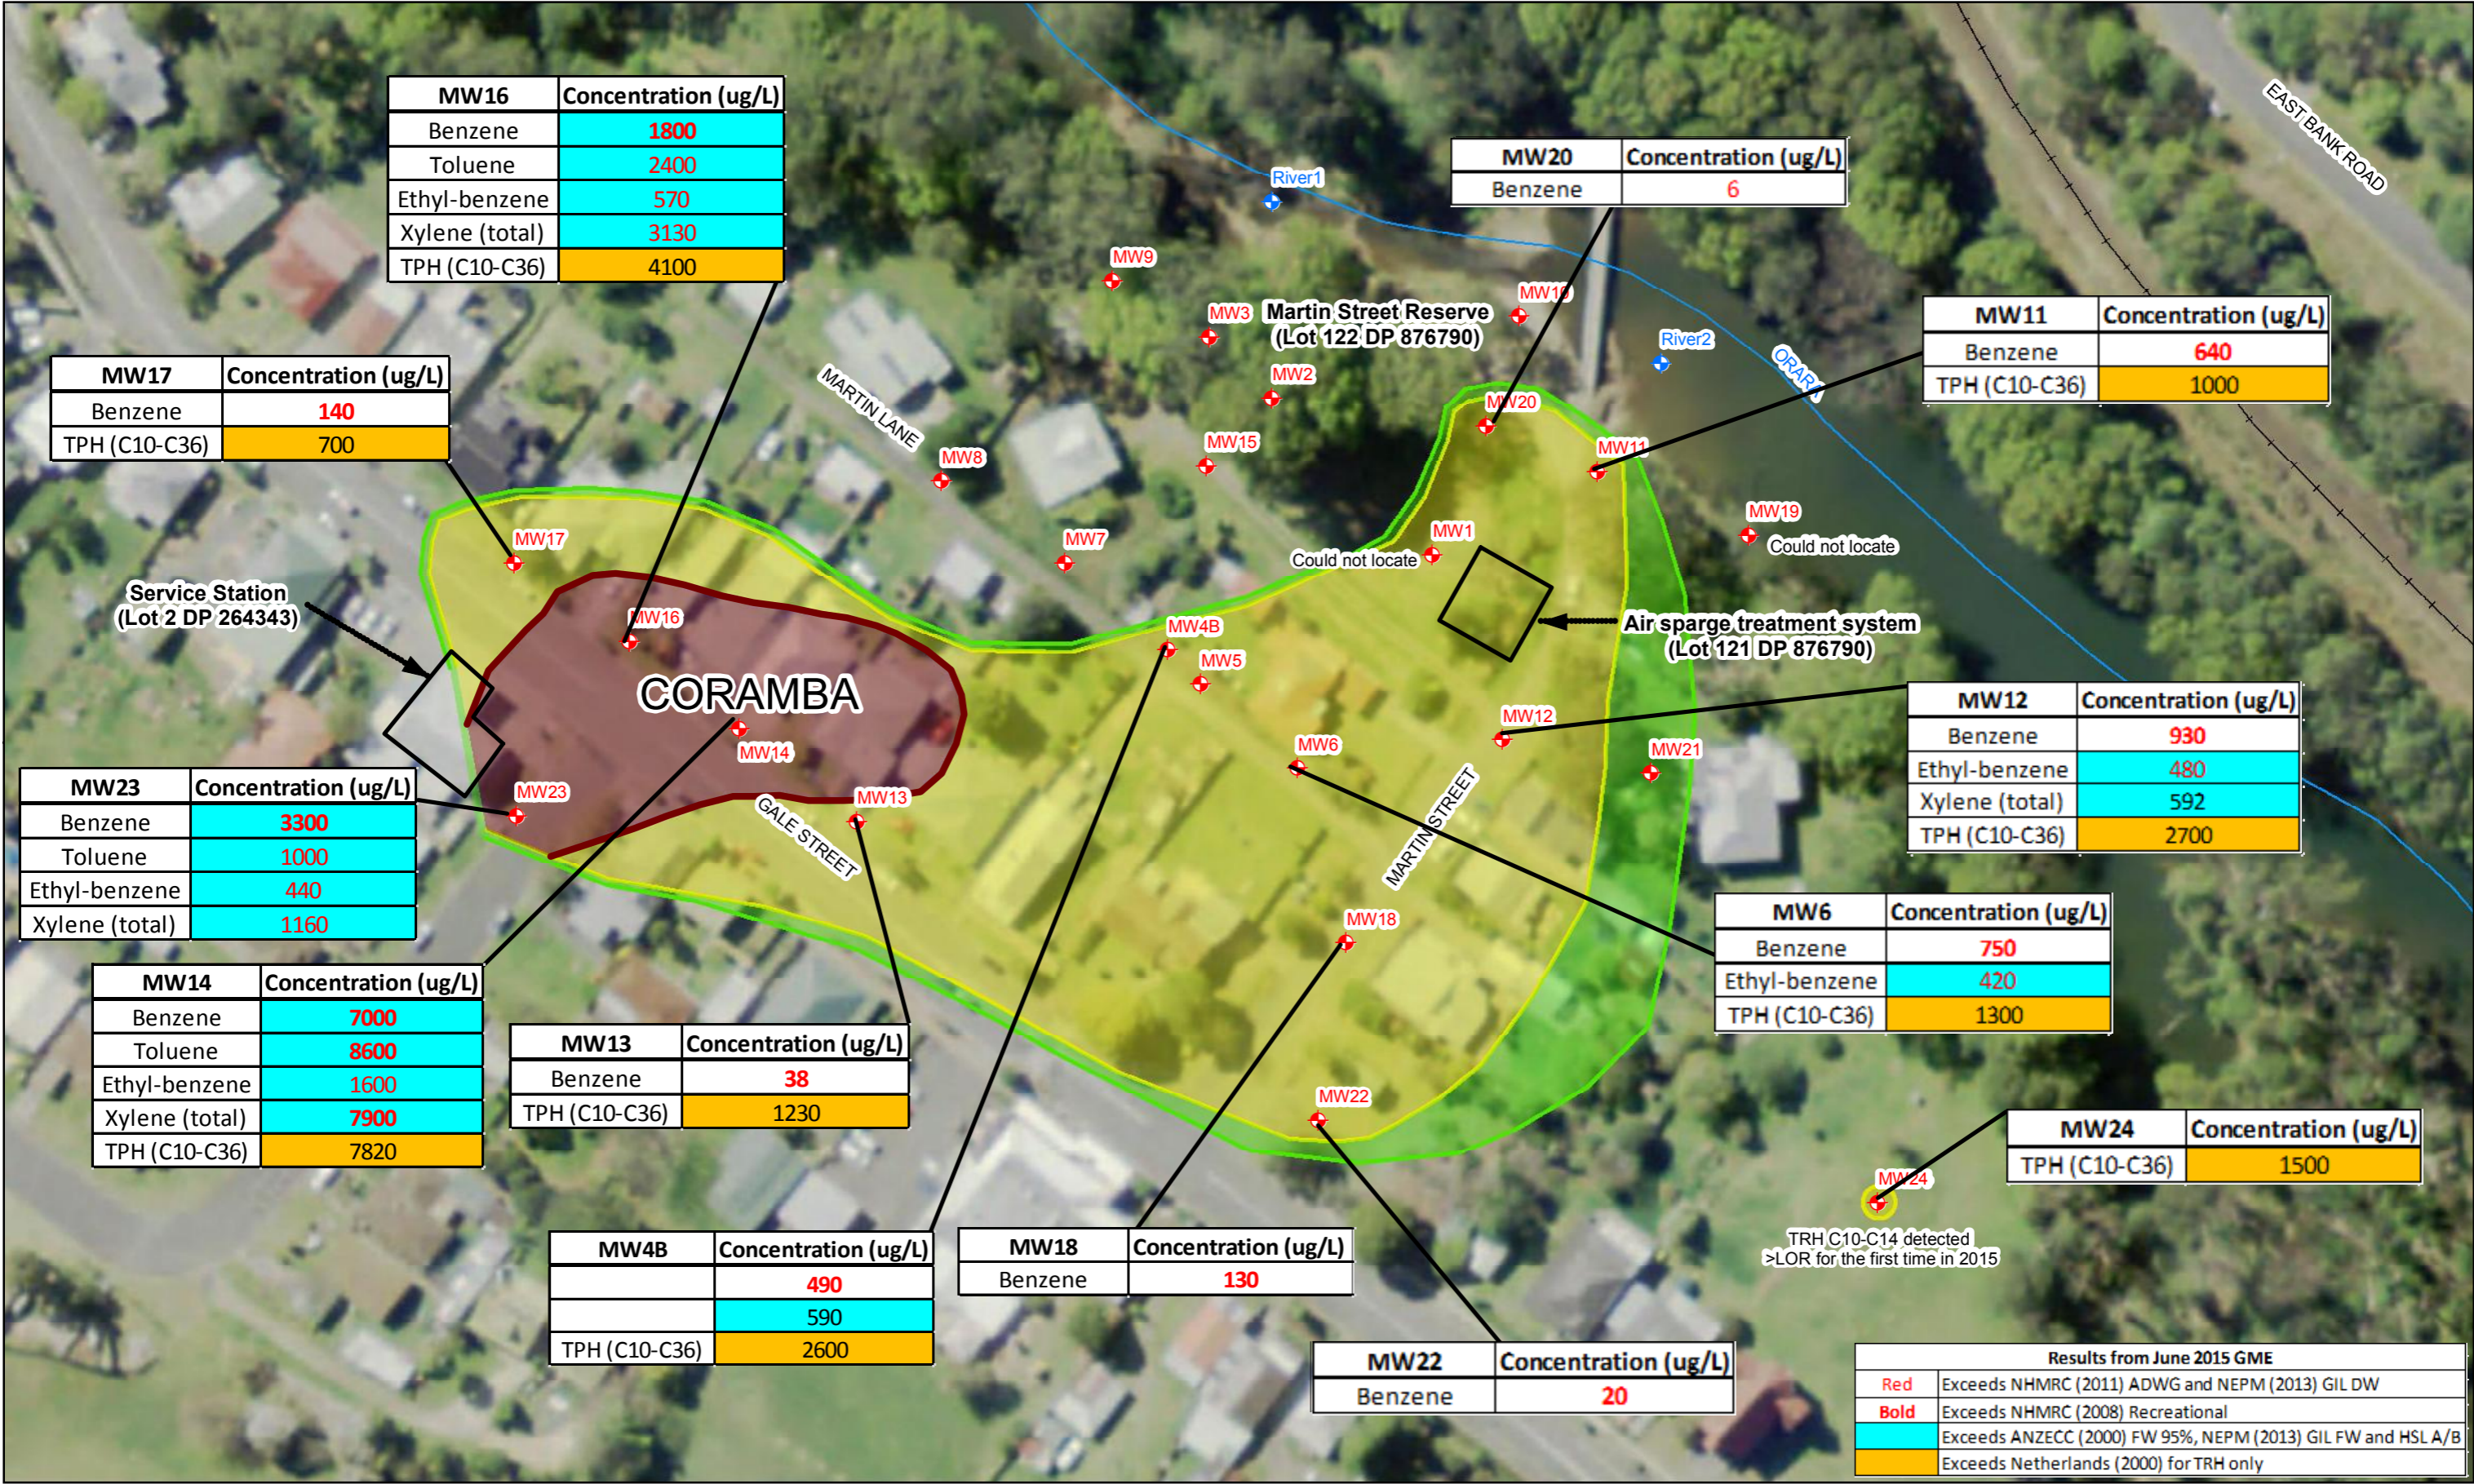
Groundwater monitoring of the existing wells was undertaken in 2006, 2008 and has been undertaken annually by WSP since 2011. The most recent groundwater monitoring event (GME) was undertaken in June 2015, three months after the air sparge treatment system was turned off. Results indicate that the overall groundwater contamination appears to be decreasing or stabilising, however nine wells still contain Benzene, Toluene, Ethylbenzene, Xylene (BTEX) and Total Recoverable Hydrocarbon (TRH) concentrations above the adopted groundwater assessment criteria. These impacted wells are located adjacent to the service station and extend down to the Orara River. A dissolved benzene plume has been identified in the vicinity of the service station, which is reportedly decreasing in size, however contaminant impact was still identified as far down gradient as the Orara River (see Figure 2-1).
