Coffs Harbour City Council

Coramba Groundwater Monitoring - April 2017

Groundwater Monitoring Report

August 2017

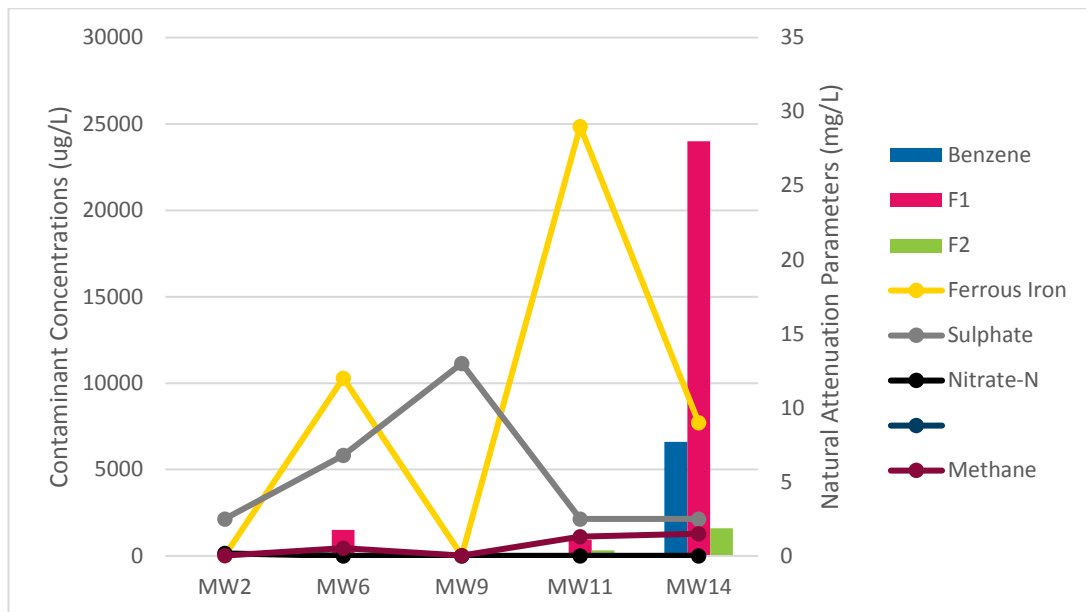
Figure 6-3 Natural Attenuation Indicators vs COPC Concentrations – April 2017

For the purpose of evaluating whether natural attenuation of hydrocarbon contaminants was likely to be occurring at the site, key geochemical parameters were analysed, as summarised in Table 6 in Appendix C. Illustrative representations of the natural attenuation indicators and concentrations of COPC across the site are presented in Figure 6-3. For the purposes of the below figure, where concentrations were below the laboratory LOR, half the LOR was used.

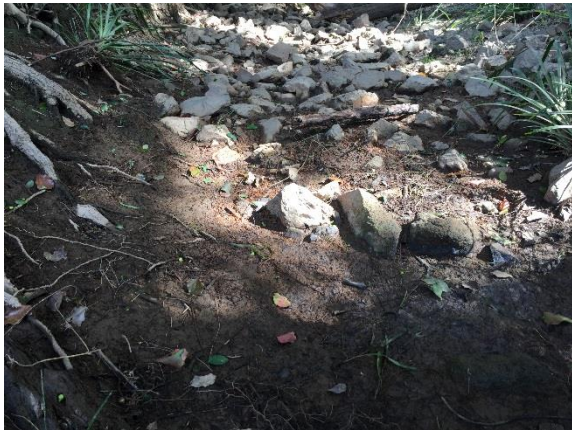
Photograph 5. River bed near previous groundwater discharge point adjacent to the Orara River.

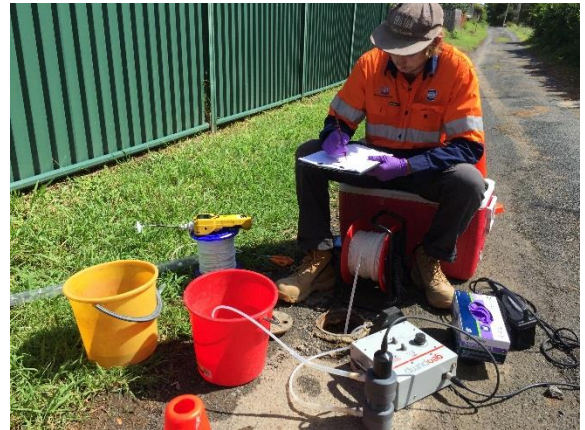
Photograph 6. Groundwater sampling undertaken in April 2017.
