## Ecohealth indicators

# Coffs Coastal Catchments REPORT CARD 2016

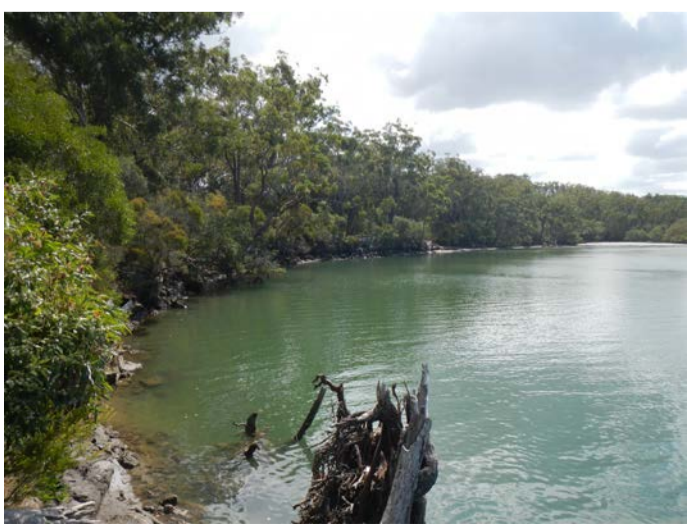
A healthy intact riparian zone in Coffs Creek estuary. Photo © Coffs Harbour City Council.

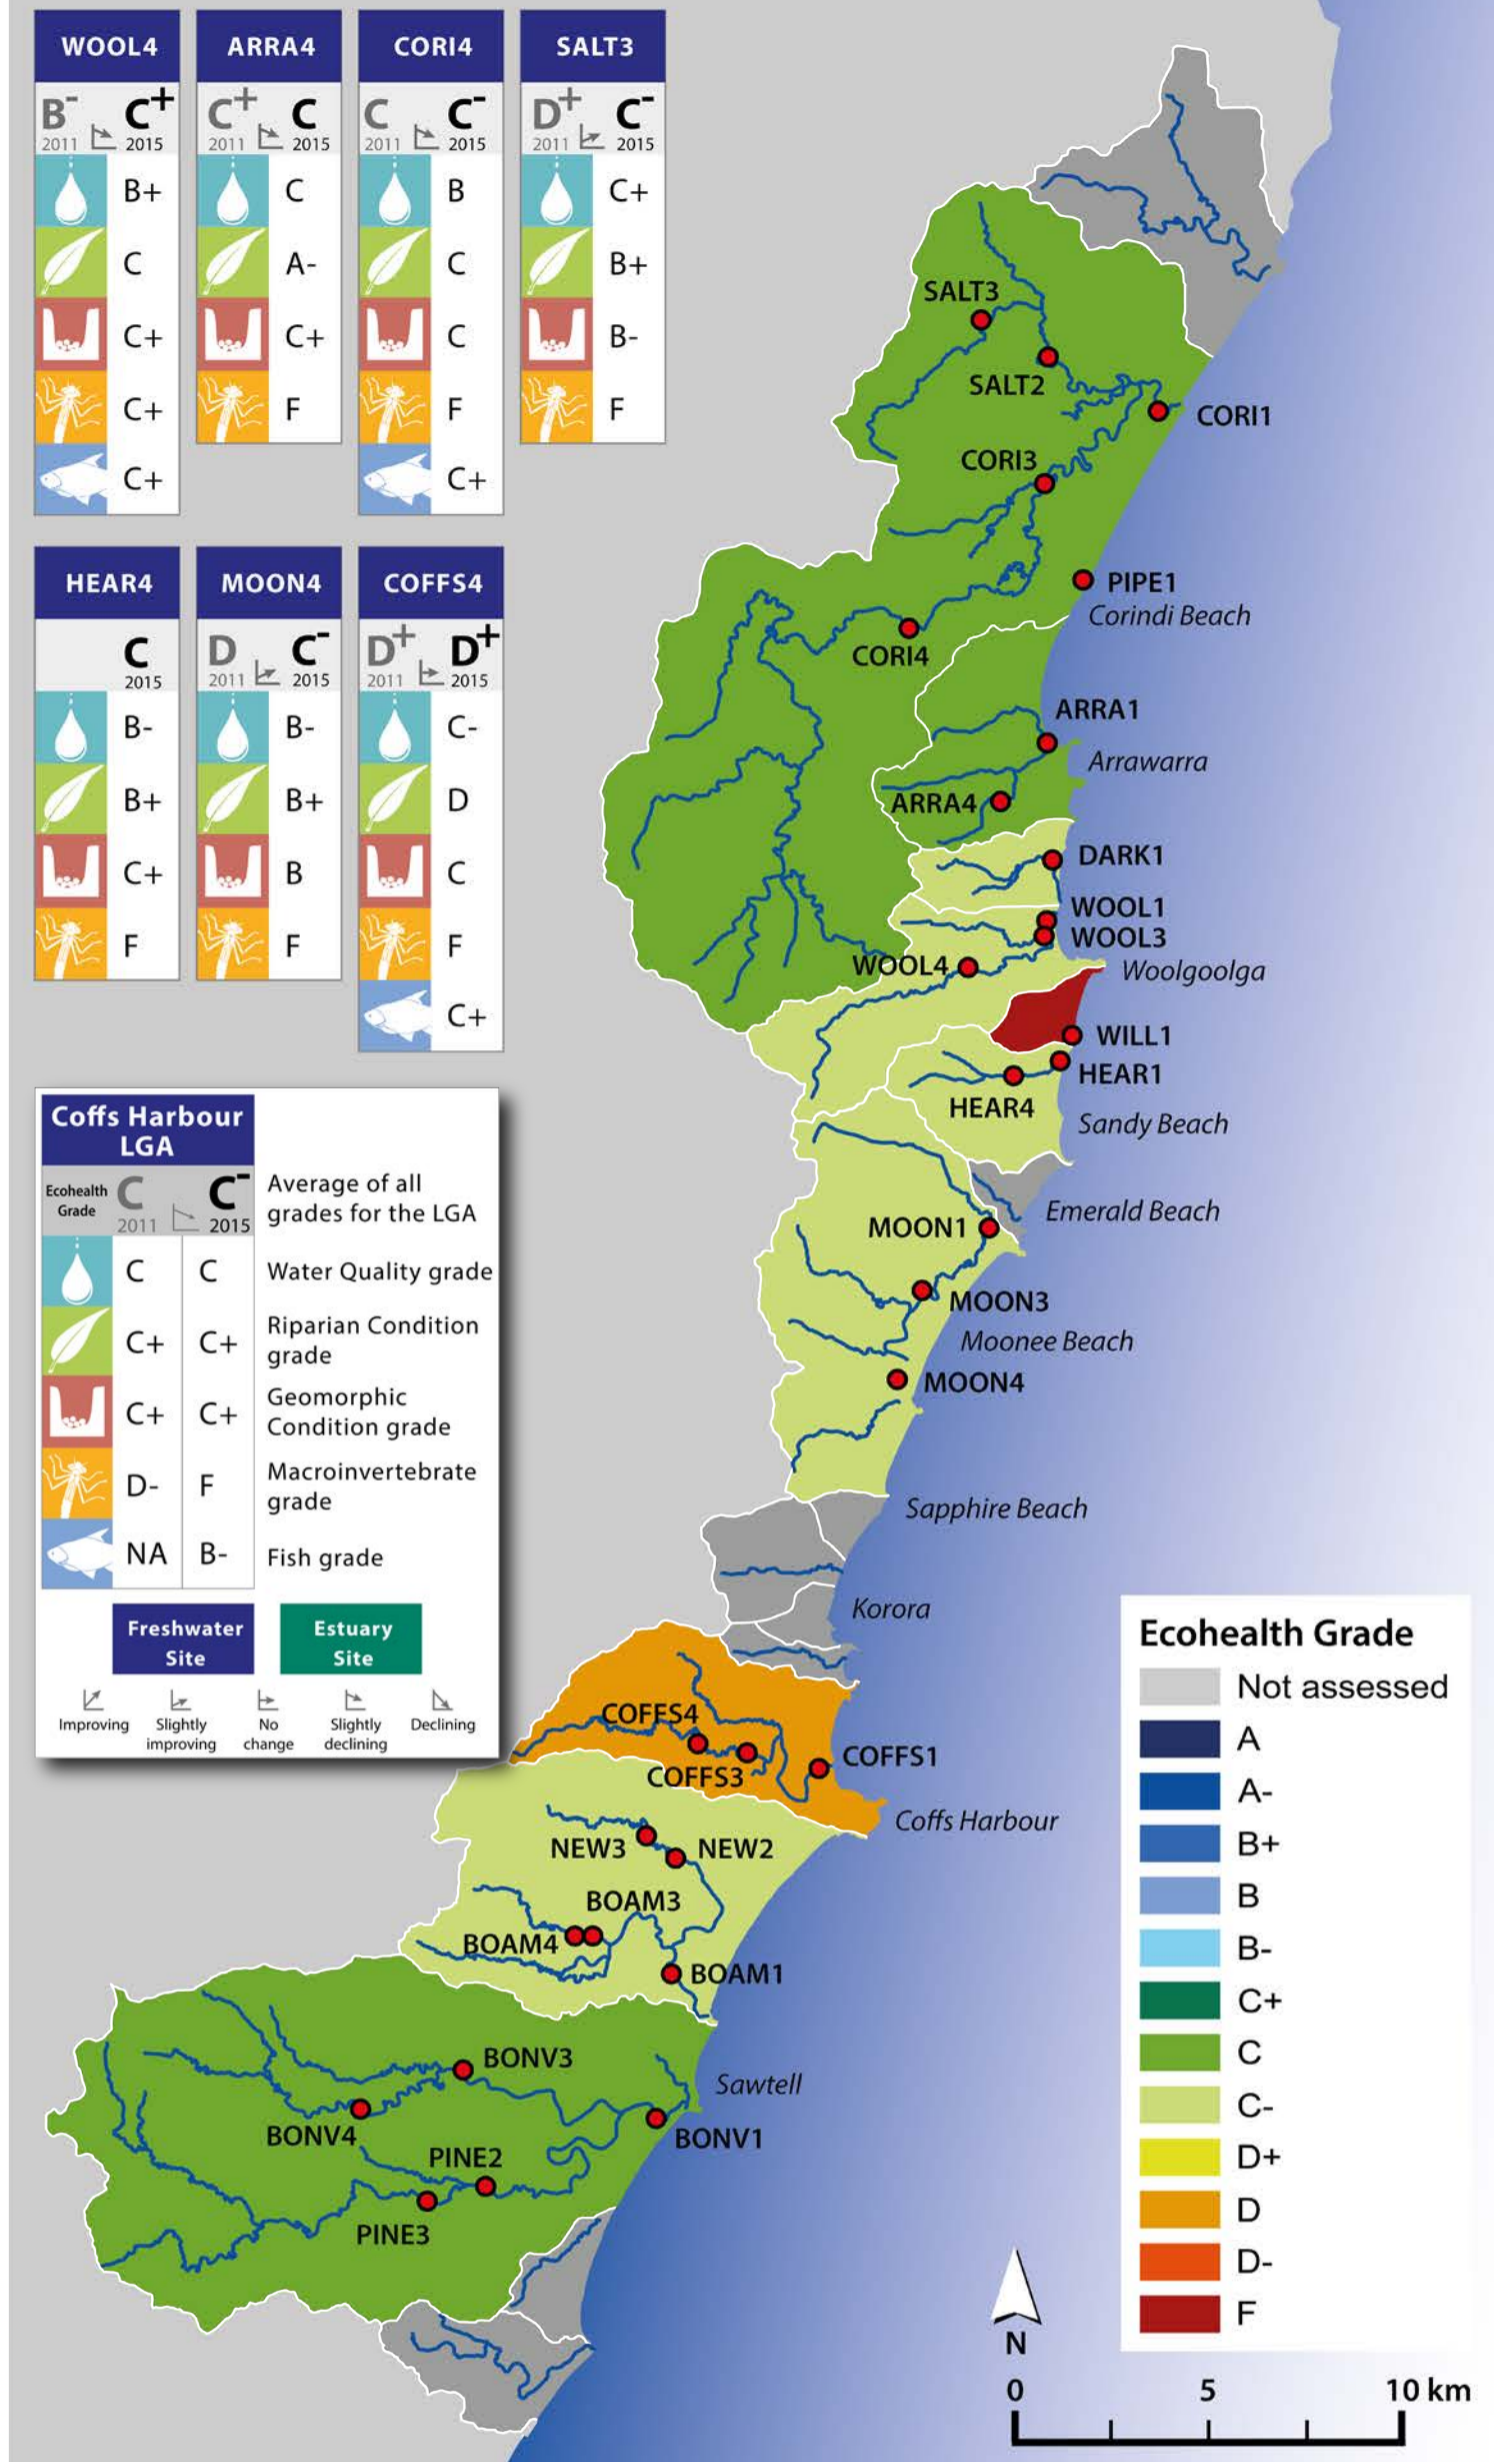
<b>CORI1</b> 2011: B+ 2015: C+ Water Quality: C+ Riparian: C Geomorphic: C+ Macroinvertebrate: C+ Fish: C+	<b>CORI3</b> 2011: C 2015: C Water Quality: C Riparian: C Geomorphic: C Macroinvertebrate: C Fish: C	<b>SALT2</b> 2011: C+ 2015: D- Water Quality: D- Riparian: C Geomorphic: C Macroinvertebrate: F Fish: C+	<b>PIPE1</b> 2011: C- 2015: C- Water Quality: C- Riparian: C Geomorphic: C Macroinvertebrate: F Fish: C+
<b>ARRA1</b> 2011: C 2015: C+ Water Quality: C+ Riparian: A- Geomorphic: C+ Macroinvertebrate: F Fish: C+	<b>DARK1</b> 2011: D+ 2015: C- Water Quality: C- Riparian: B+ Geomorphic: C Macroinvertebrate: F Fish: C+	<b>WOOL1</b> 2011: C+ 2015: D+ Water Quality: D+ Riparian: C Geomorphic: C Macroinvertebrate: F Fish: C+	<b>WOOL3</b> 2011: D 2015: C- Water Quality: C- Riparian: C Geomorphic: C Macroinvertebrate: F Fish: C+
<b>WILL1</b> 2011: F 2015: F Water Quality: F Riparian: B+ Geomorphic: C+ Macroinvertebrate: F Fish: C+	<b>HEAR1</b> 2011: C- 2015: C- Water Quality: C- Riparian: B+ Geomorphic: C Macroinvertebrate: F Fish: C+	<b>MOON1</b> 2011: C 2015: C Water Quality: C Riparian: C Geomorphic: C Macroinvertebrate: F Fish: C+	<b>MOON3</b> 2011: D 2015: D+ Water Quality: D+ Riparian: C Geomorphic: C Macroinvertebrate: F Fish: C+

<b>COFFS1</b> 2011: B- 2015: C- Water Quality: C- Riparian: C+ Geomorphic: C+ Macroinvertebrate: D- Fish: NA	<b>COFFS3</b> 2011: D- 2015: F Water Quality: F Riparian: C+ Geomorphic: C+ Macroinvertebrate: F Fish: NA	<b>BOAM1</b> 2011: C 2015: B Water Quality: B Riparian: C+ Geomorphic: C+ Macroinvertebrate: D- Fish: NA	<b>BOAM3</b> 2011: D+ 2015: D Water Quality: D Riparian: C+ Geomorphic: C+ Macroinvertebrate: D- Fish: NA
<b>NEW2</b> 2011: C+ 2015: D- Water Quality: D- Riparian: C+ Geomorphic: C+ Macroinvertebrate: D- Fish: NA	<b>BONV1</b> 2011: B- 2015: B+ Water Quality: B+ Riparian: C+ Geomorphic: C+ Macroinvertebrate: D- Fish: NA	<b>BONV3</b> 2011: C 2015: D+ Water Quality: D+ Riparian: C+ Geomorphic: C+ Macroinvertebrate: D- Fish: NA	<b>PINE2</b> 2011: B- 2015: D+ Water Quality: D+ Riparian: C+ Geomorphic: C+ Macroinvertebrate: D- Fish: NA
<b>BOAM4</b> 2011: D+ 2015: C+ Water Quality: C+ Riparian: C+ Geomorphic: C+ Macroinvertebrate: D- Fish: NA	<b>NEW3</b> 2011: D+ 2015: D+ Water Quality: D+ Riparian: C+ Geomorphic: C+ Macroinvertebrate: D- Fish: NA	<b>BONV4</b> 2011: C+ 2015: B- Water Quality: B- Riparian: C+ Geomorphic: C+ Macroinvertebrate: D- Fish: NA	<b>PINE3</b> 2011: C- 2015: C Water Quality: C Riparian: C+ Geomorphic: C+ Macroinvertebrate: D- Fish: NA

Overall 2015 Ecohealth grades for catchments in the Coffs Harbour Local Government Area. Site grades show the indicator grades for each site in 2015 and the change in the overall site grade between 2011 and 2015. © 2016 Aquatic Ecology and Restoration Research Group, UNE.

A total of 31 sites in 14 waterways were used to calculate an overall condition of C- for the Coffs Harbour catchments (see overleaf).
